Excavated Exposed Face Instability

Following are examples of excavated wall faces that did not maintain integrity and stability.

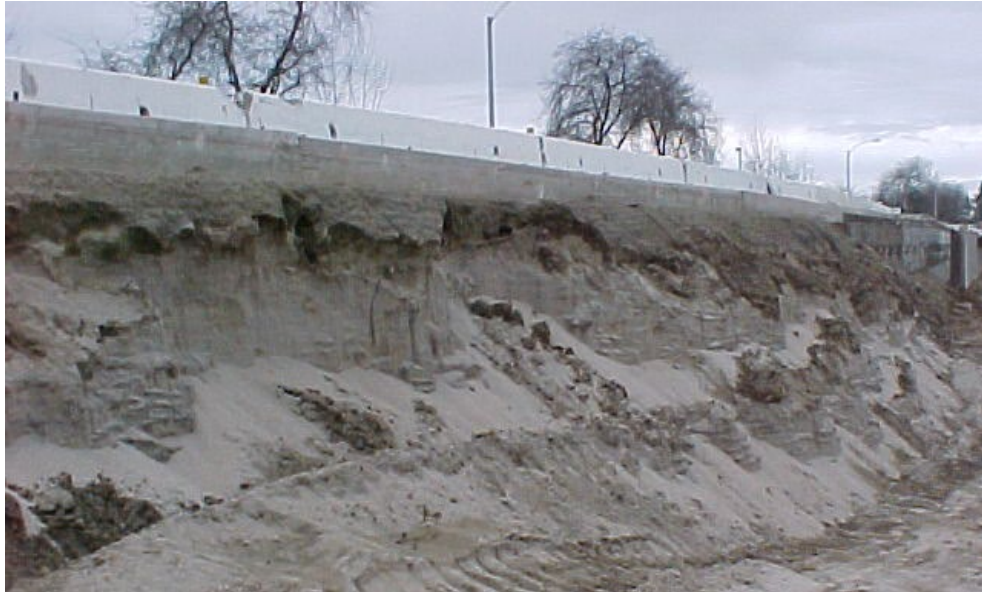
Figure 1. Native sandy silt material that will not maintain a vertical stable cut.

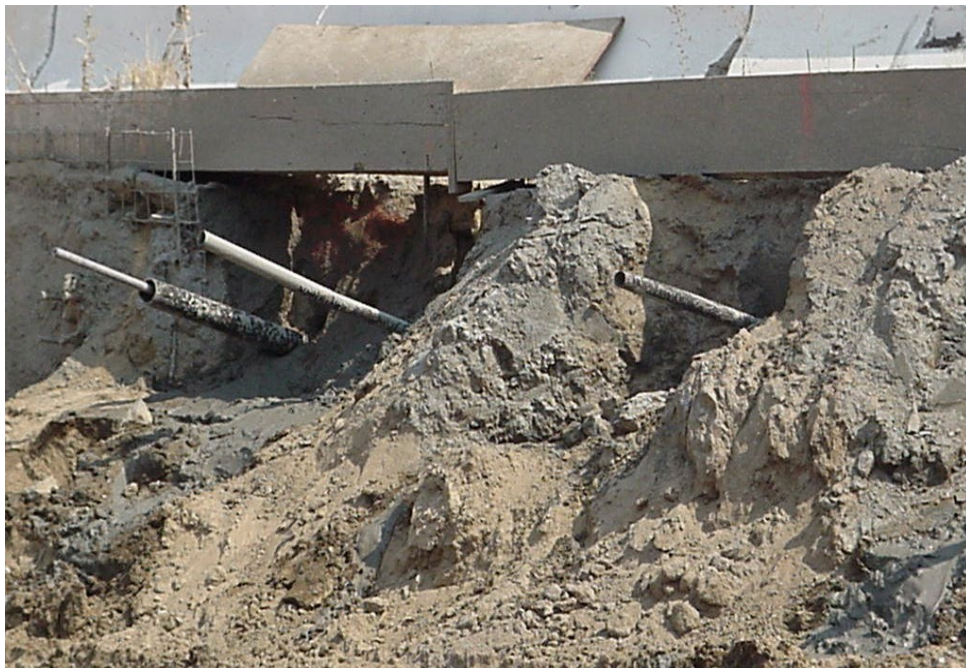
Figure 2. Another example of wall face instability due to sandy material.

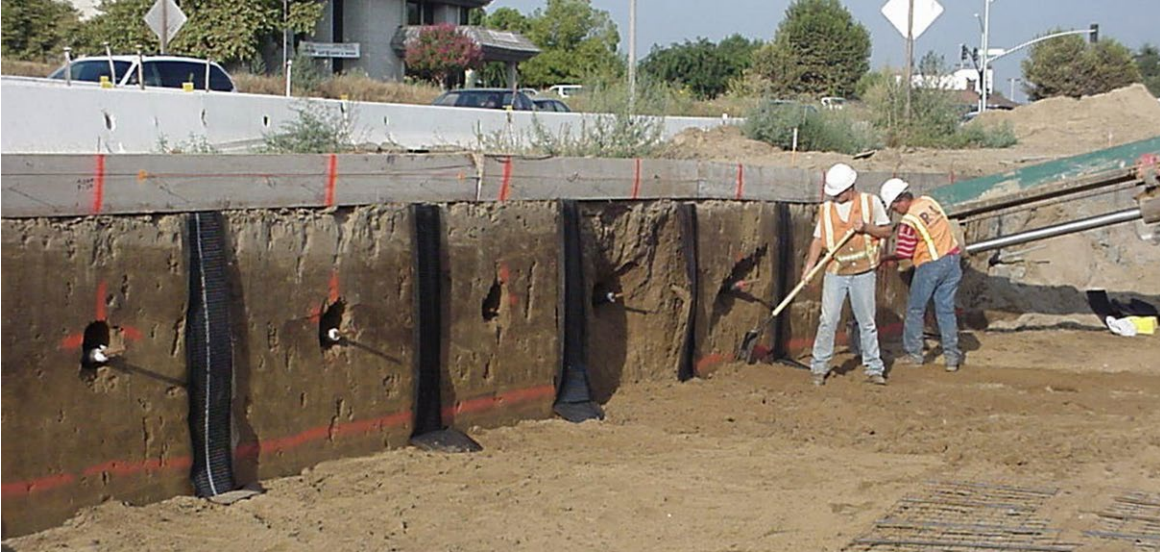
Figure 3. Material that stands initially, may slough over time as the soil loses moisture. Thus, even apparently good soil material may slough.

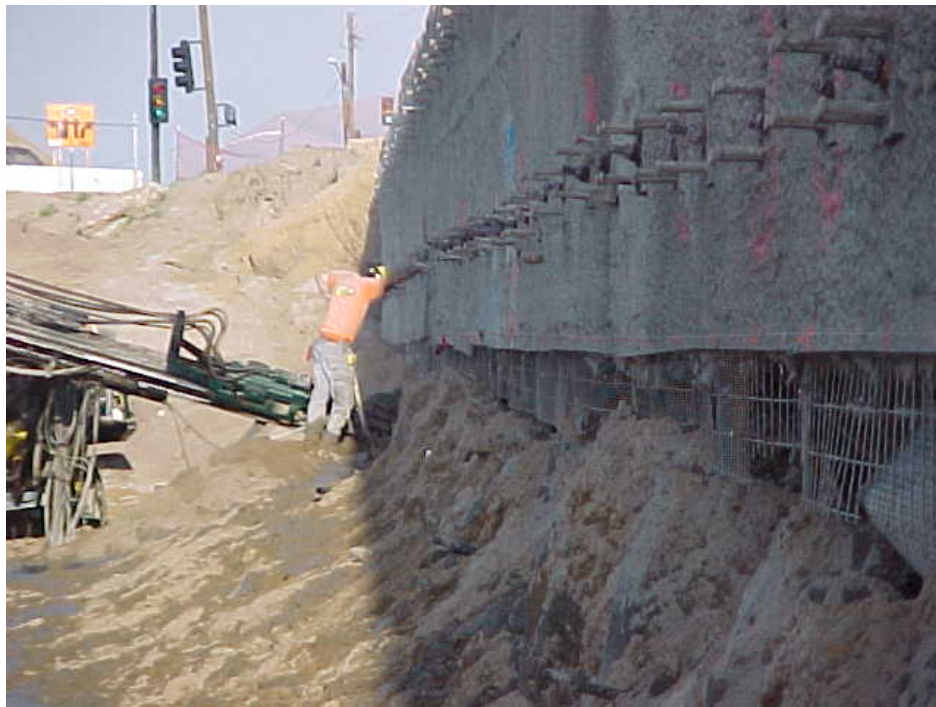
Figures 4 through 9 depict a time lapse event that led to a wall failure. Work occurred on a Friday shift culminating in a wall collapse Monday morning.

Figure 4. Improper berm and native sandy material sloughing on Friday from behind the previously constructed 2 layer/rows of soil nails.

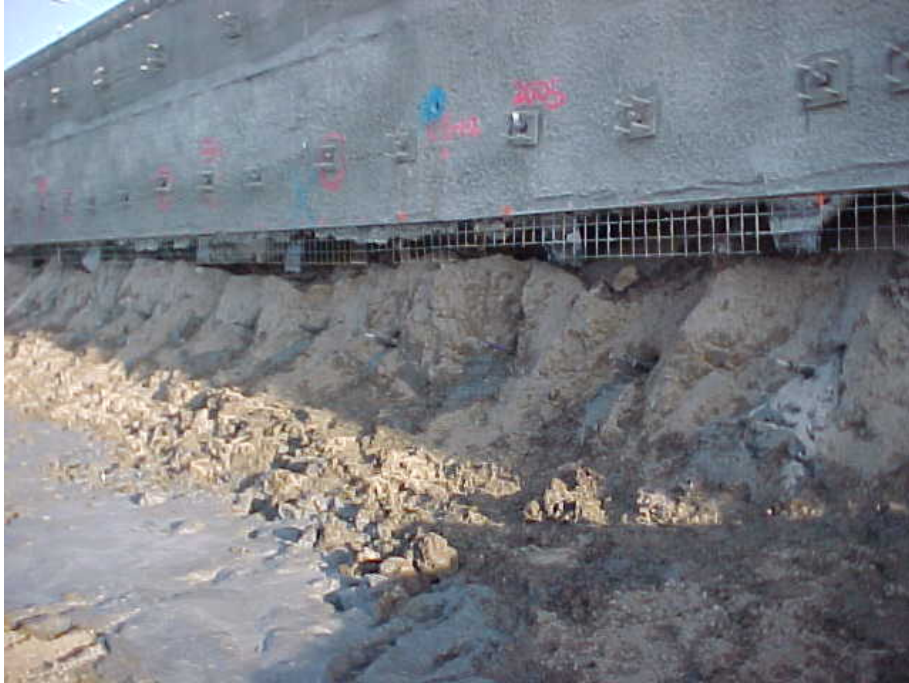
Figure 5. As work progressed through the day and afternoon more material sloughs from behind the wall due to construction activity and loss of moisture.

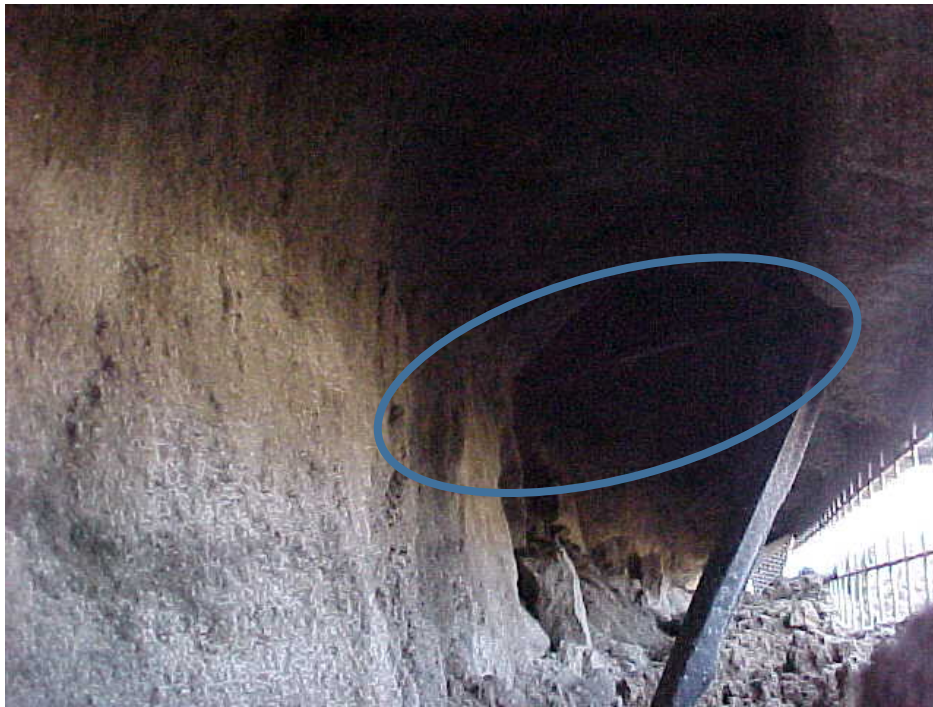
Figure 6. Picture from inside and behind shotcrete to illustrate the amount of material loss. Note the exposed soil nail from the previously completed row above.

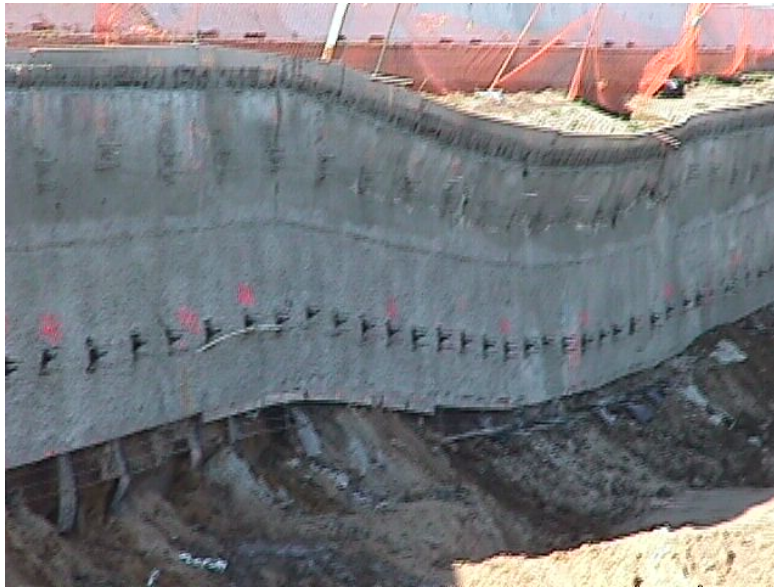
Figures 4 through 6 depicts what contributed to the wall failure that is depicted in Figures 7 through 9 that was observed the following Monday morning.

Figure 7. Wall collapsed due to progressive loss of material from behind the wall, noted in the previous pictures. Notice the deteriorated berm and loss of material

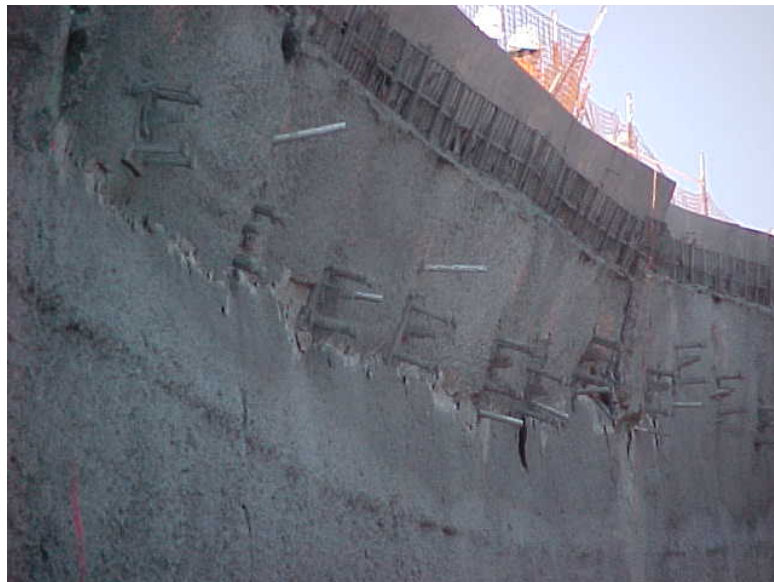
Figure 8. With the loss of the supporting soil behind the wall, the wall failed similar to a beam in bending. The top portion of the wall buckled outward and broke.

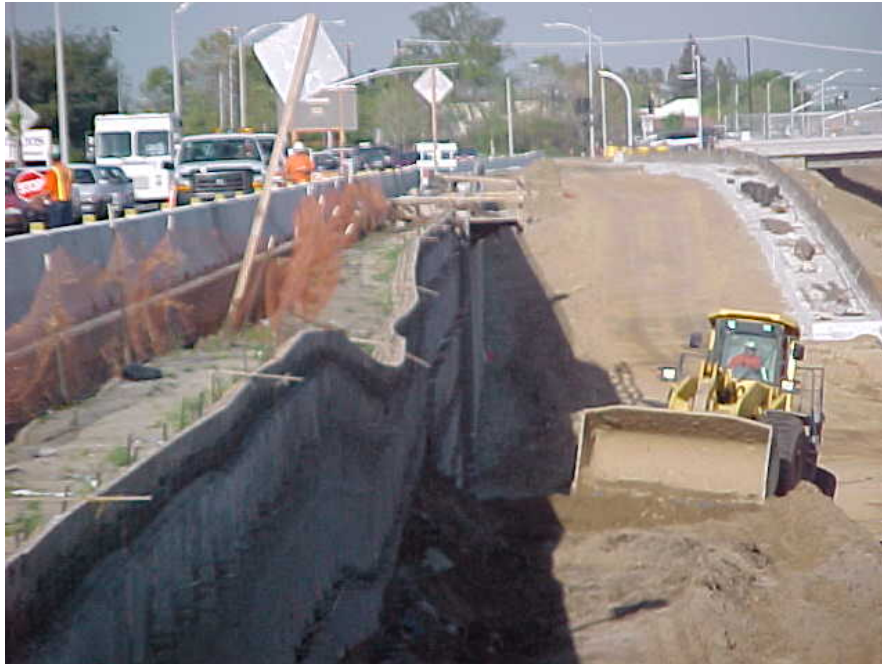
Figure 9. Illustrating the magnitude of material loss due to wall face instability and potential safety hazard for the travelling public. The berm being placed is to stabilize the failed section to prevent further collapse.
