Stem to Deck Construction Joints

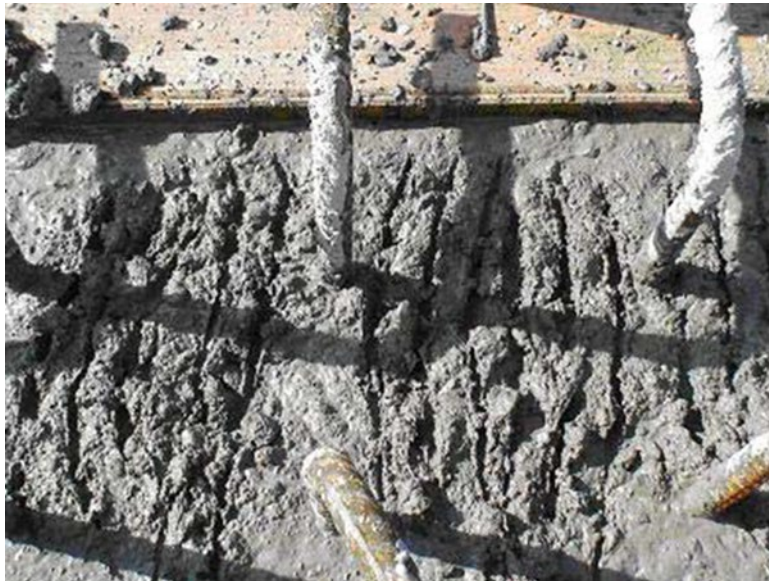
Figure 1. Example of Acceptable Roughened Surface

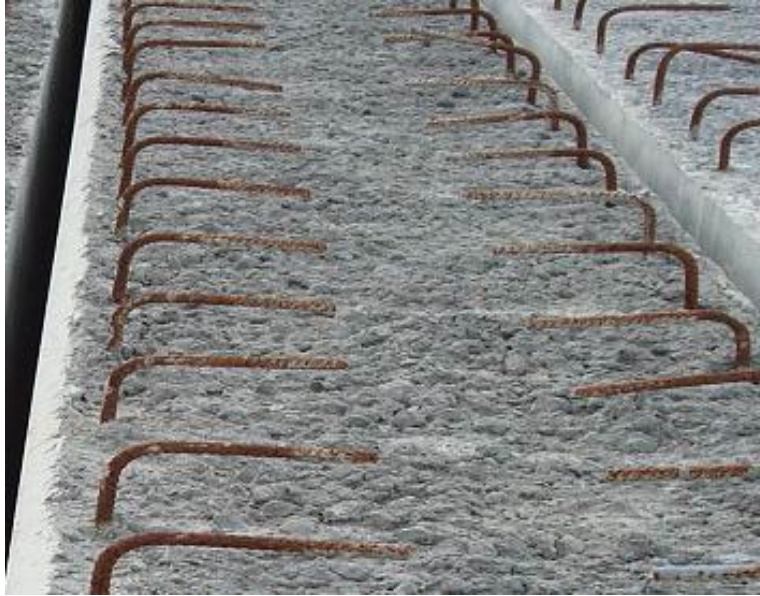
Figure 2. Example of Acceptable Roughened Surface
