**Caltrans Hydromodification/Stream Channel Stability  
Requirements Guidance  
*Storm Water Best Management Practices  
Rapid Assessment of Stream Crossings  
Higher Level Stream Stability Analysis***

**November 2023**

**California Department of Transportation  
1120 N Street  
Sacramento, California 95814**

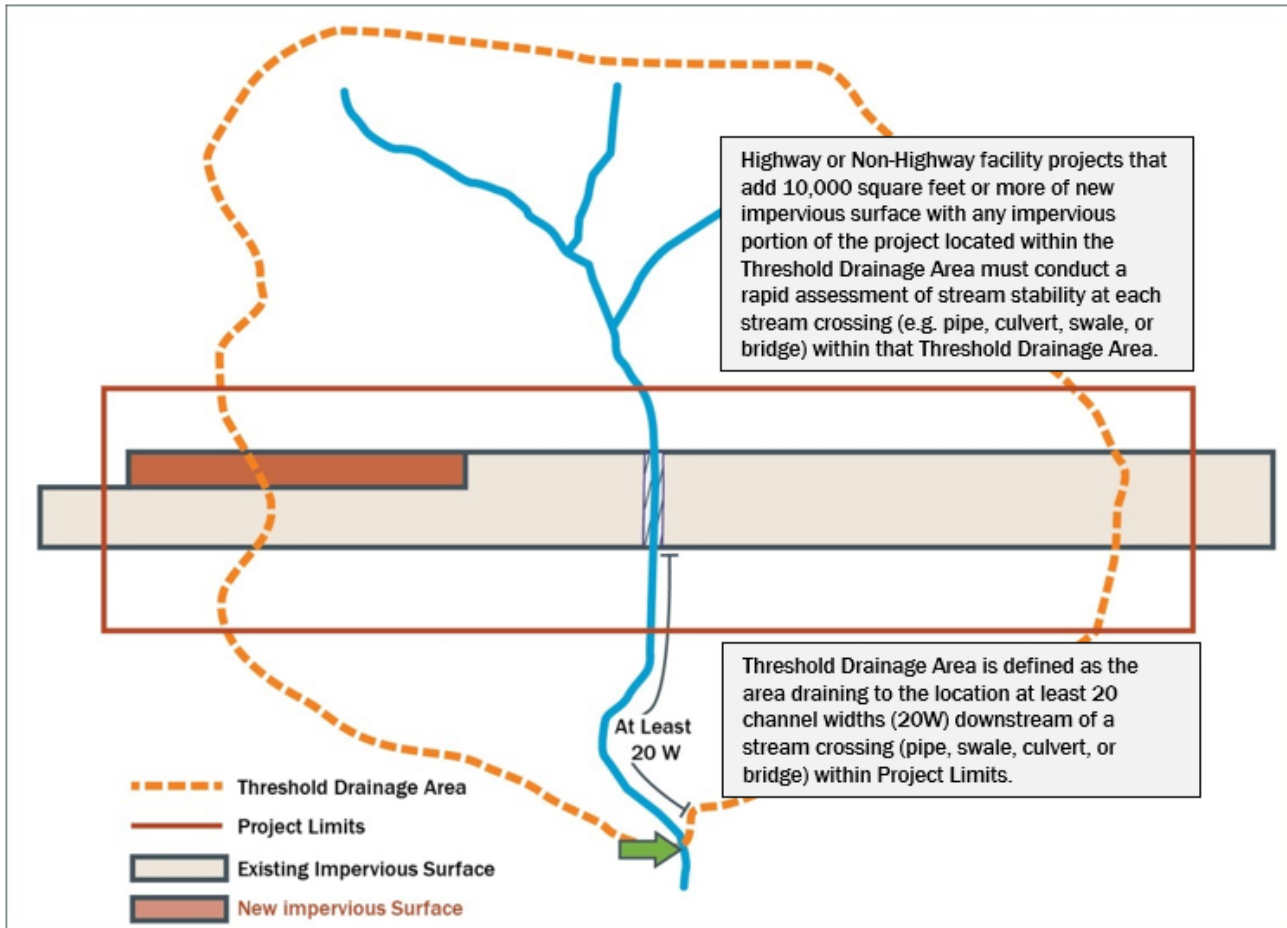
**Figure 1. Definition of Threshold Drainage Area (TDA)**

*The TDA is delineated with a dashed line. The TDA drains to the point marked with the green arrow.*

*The TDA drainage network is shown in blue, with the stream crossing (culvert) shown as a straight purple line*

The next step is to determine whether at least part of the new impervious surface lies within a threshold drainage area (TDA). The TDA is a key concept underlying the procedure outlined in this manual. The permit text (Section C3.10.9.1) should be consulted for details. The permit defines the TDA as the area draining to a location at least 20 channel widths downstream of a stream crossing (Figure 1).

**Step 2.** After estimating  $W$ , the engineer should inspect the channel, starting at the downstream end of the stream crossing (bridge, pipe, or culvert) of interest and proceeding  $20W$  (twenty widths) downstream. The downstream end of the  $20W$ -long reach is the control point for TDA delineation (see green arrow in Figure 1). If this  $20W$ -long reach includes any major discontinuities in channel characteristics, such as steps, culverts, grade controls, tributary junctions, or other features or structures that significantly affect the shape or behavior of the channel, the reach should extend at least  $5W$  to  $7W$  past the discontinuity, even if this requires a longer reach than  $20W$ .

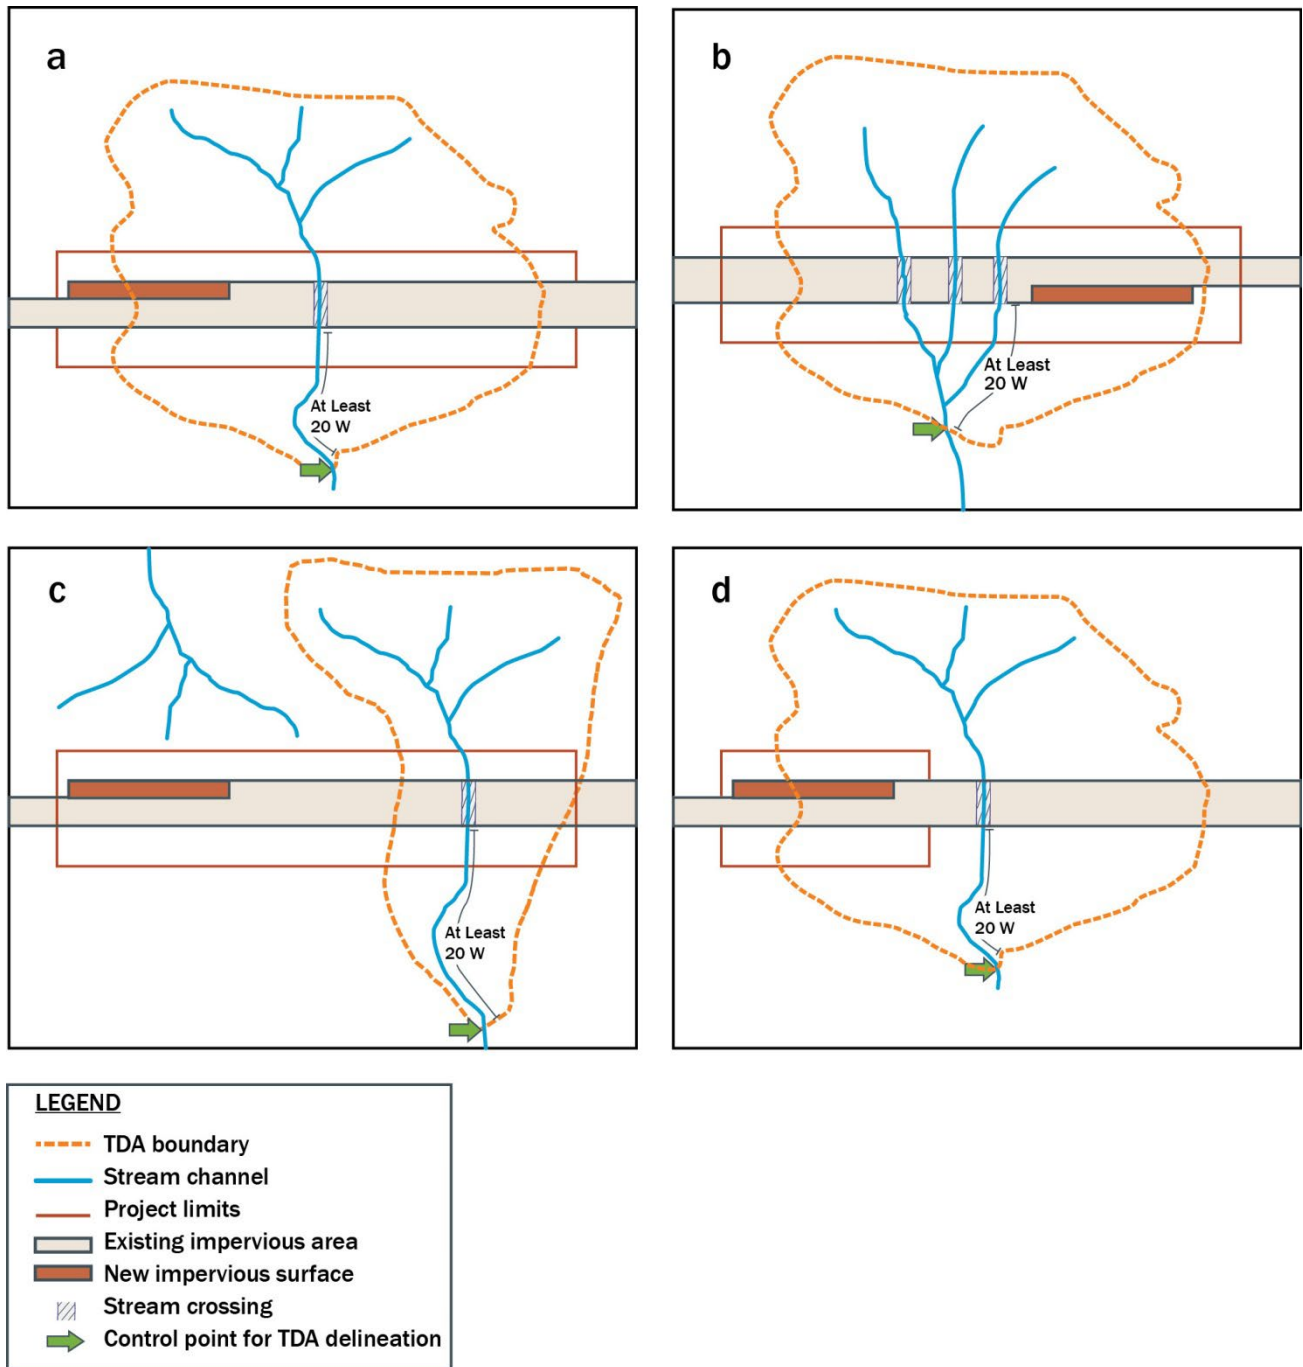
**Figure 3. RSA Requirements**

Schematics illustrating Projects Involving 10,000 Square Feet or More of Net New Impervious Area That Do (a and b) and Do Not (c and d) Require an RSA. (a) > 10,000 square feet of new impervious area within TDA, RSA required; (b) Several TDAs that are tributary to a larger one, and > 10,000 square feet new impervious area within largest TDA, RSA required; (c) New impervious area entirely outside TDA, RSA not required; (d) Project does not contain any stream crossings, RSA not required. See text for more detail.

Figure 3 provides some example TDA delineations.

- Figure 3a shows a project that contains a stream crossing and new impervious surface. Even though only part of the project and only part of the new impervious surface is within the TDA, if the impervious area  $\geq 10,000$  square feet, an RSA will be required. Furthermore, if the new impervious surface were comprised of several small parcels with total surface area  $\geq 10,000$  square feet, an RSA would be required.

- Figure 3b shows a project with multiple stream crossings, but all TDAs are contained within a single TDA when the watershed is delineated using the most downstream 20W control point. In this case the entire new impervious surface is within the TDA, although the project limits extend outside the TDA. If net new impervious area  $\geq 10,000$  square feet, an RSA is required.

- Figure 3c provides an example of a project that contains a stream crossing, but the entire new impervious surface lies outside the TDA delineated from a point 20W downstream from the crossing. No RSA is required.

- Figure 3d depicts a project that does not contain a stream crossing within the project limits. No RSA is required.

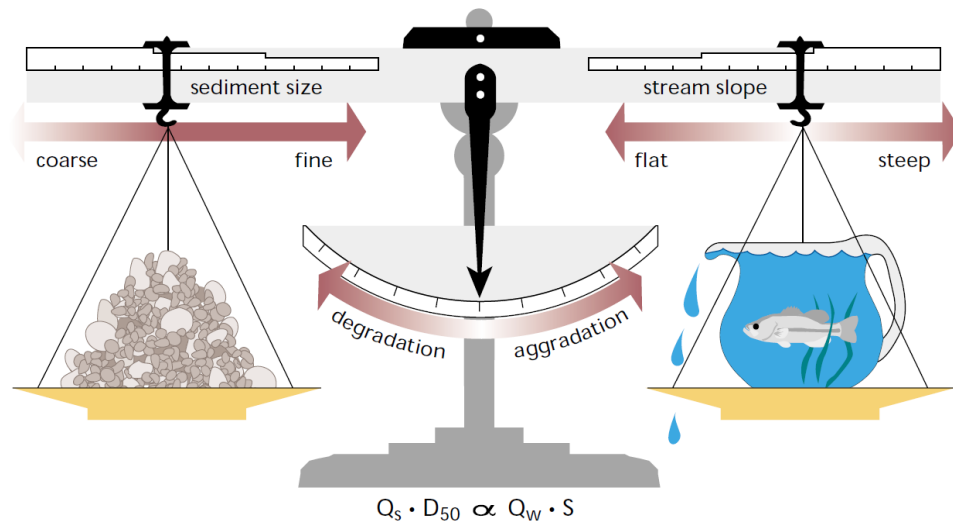
**Figure 5. Schematic Illustrating Lane’s Relation**

*In Alluvial Channels that are free to adjust their boundaries through erosion and sedimentation, changes in any of the four quantities in the relation will produce adjustments in the other three to maintain equilibrium (Federal Interagency Stream Restoration Working Group 1998)*

Although complex models and considerable professional judgment is needed for precise prediction of fluvial response to hydromodification at a given site, Lane’s relation is very useful for understanding how and why channels behave as they do (Figure 5). This simple relation is a key tool for rapid stability assessments (Lagasse et al. 2012). Lane’s relation (Lane 1955) states that the driving and resisting forces in a fluvial system respond to each other to create a balance. The driving forces may be expressed as the product of water discharge and channel slope, and the resisting forces as the product of sediment discharge and sediment size. Mathematically, the Lane relation is

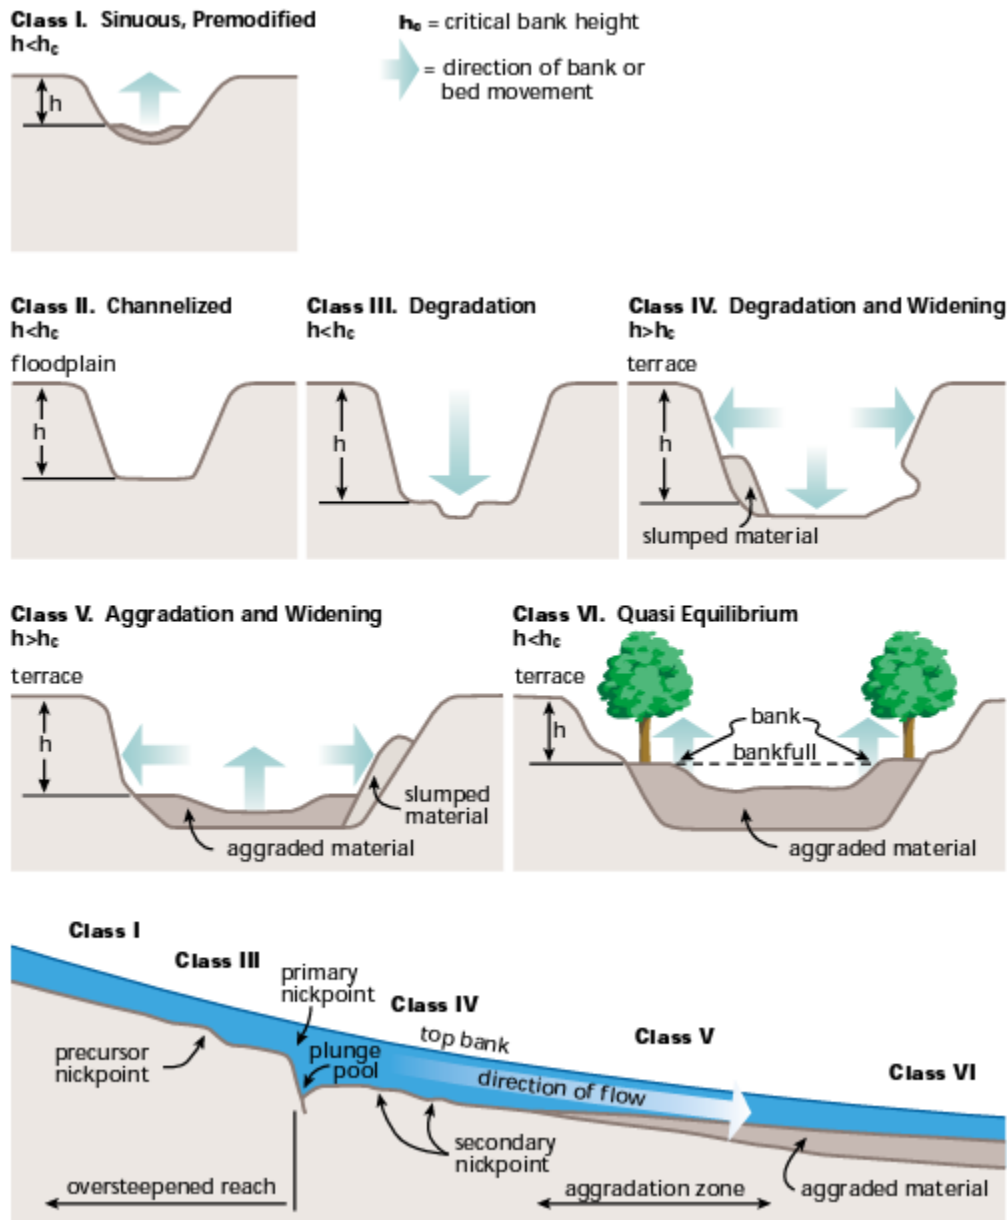
Figure 7. Schematic of Conceptual Channel Evolution Model (FISRWG 1998)

Model from Schumm et al. (1984), and Simon (1989)

Patterns of erosion associated with channel incision seem to follow a sequence of steps that have been described in a conceptual channel evolution model (CEM), shown in Figure 7. There are several versions of the CEM, but the one presented here is representative. The long profile at the bottom of Figure 7 is typical of the changes that may be observed as one moves from place to place along an actively incising stream; the smaller cross-sectional drawings are typical for each class or stage, but also depict the sequence of changes that occur at a fixed location as time passes. First, natural or “premodified” channels will be sinuous, with more or less stable banks, and may even be slightly aggradational (Class or Stage I). Recent work published by Cluer and Thorne (2012) suggests that CEM Class I is preceded by a braided or anastomosing stage (multiple channels divided by bars and vegetated islands). Other recent research has modified the standard CEM for streams characteristic of southern California, including transitions from single thread to multithread and braided evolutionary endpoints (Hawley et al. 2012). Straightening (channelization) places a channel in Class II, but this stage often triggers vertical adjustment in the form of general bed lowering or the formation of steps or waterfalls in the bed (known as knickpoints or headcuts), which migrate upstream (Class III). Unless prevented by some erosion-resistant material in the bed (e.g., boulders, concrete, bedrock) or by a structure such as a dam, weir, or culvert, the headcut will continue to move upstream until the watershed is so small and flows are so low that the stream no longer has sufficient power to erode the bed (stream power =  $QS$ , the left side of the Lane relation). If the headcut deepens the channel enough to force banks to exceed a critical bank height,  $h_c$ , for geotechnical stability, extremely rapid channel widening via mass failure results, defined as Class IV. Bank failure may be exacerbated in some ecoregions because channel incision may lower the water table along the stream which causes adverse impacts on riparian vegetation. Class IV channels often exhibit erosion of both banks. When channels become so wide that they cannot transport the sediment load from upstream, vertical processes shift from degradation to aggradation, even though some bank erosion may continue (Class V). When deposited bars become high enough to support woody vegetation, a new channel within the enlarged, incised channel, and a Class VI form may be identified. Recent research suggests that this CEM should be expanded to include a form that often develops after Class VI that is braided (Cluer and Thorne 2013).

The most common cause of artificial entrenchment is channel incision (downcutting) in response to hydromodifications associated with development. Incision indicators are consistent with the CEM (Figure 7) and include the following (Castro 2003):

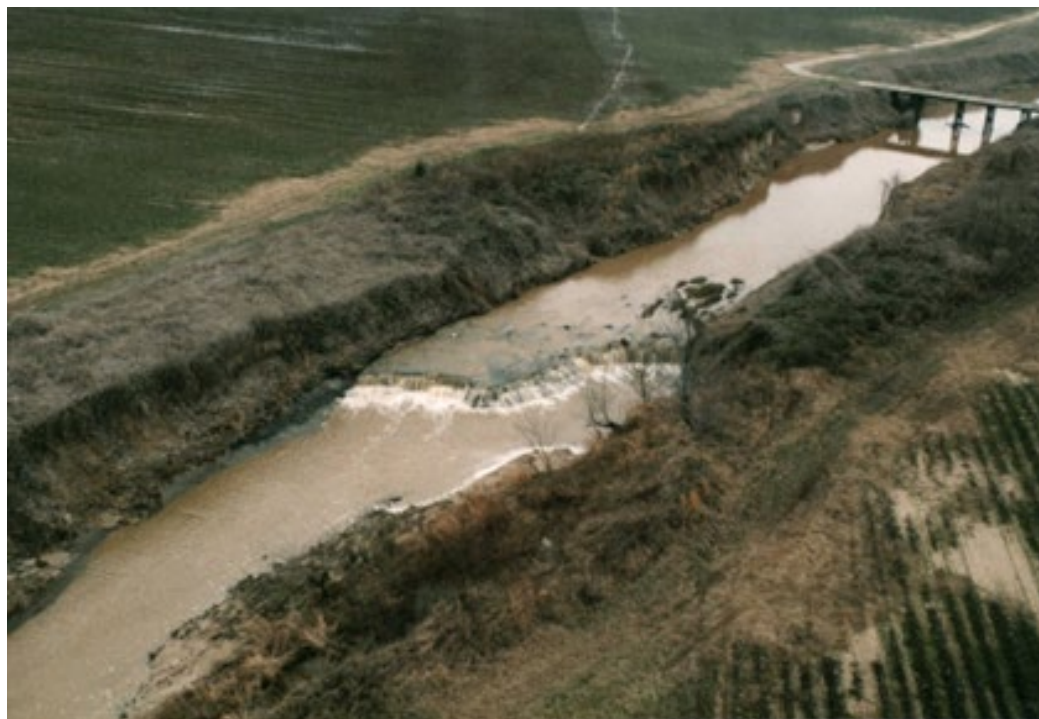
Figure 8. Headcut in Consolidated Cohesive Bed Approaching County Road Bridge

*Big Creek, MS, 1997*

Headcuts pose a particularly serious hazard to highway infrastructure (Figure 8). For example, in 1995, a railroad bridge near Kingman, Arizona, collapsed as a passenger train passed over it, injuring more than 150 people. The bridge collapse was caused by upstream migration of a headcut following heavy rains and the failure of a downstream check dam (Johnson 2006). Sediments and large wood brought into channels (particularly Classes III and IV) as a result of incision are deposited downstream in Class V and VI reaches. Accelerated deposition can fill a channel, forcing flows over the banks and damaging or destroying roadways or embankments. Excessive amounts of large wood can also lodge on bridge piers or block entrances to pipes and culverts. Even dynamically stable channels can threaten highway rights-of-way when upstream meanders migrate toward them (Figure 9). A fuller description of the implications of stream channel instability for highway structures is provided by Lagasse et al. (2012). The FHWA publication, *A Field Guide for Bridge Inspectors* (FHWA 2009) is a handy, well-illustrated pocket guide with checklists for assessing symptoms of instability. Caltrans guidance is available for culvert inspections also (Caltrans 2021).

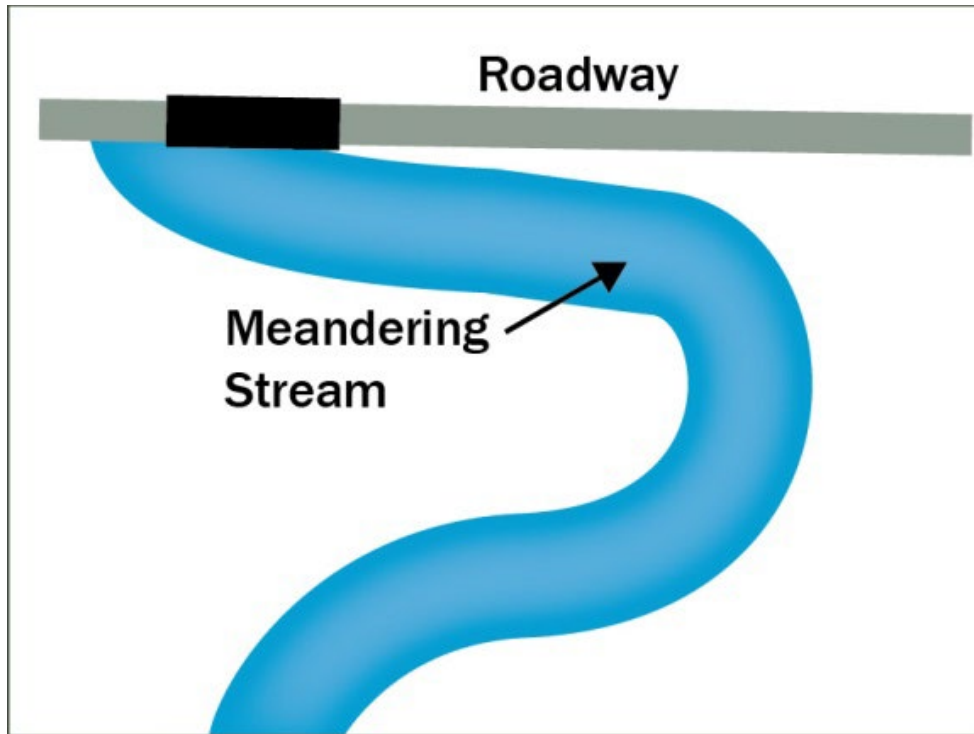
**Figure 9. Meander Threatening a Roadway**

*Most rapid erosion along a bend occurs on the concave bank just downstream of the bend apex.*

More rapid transmission of precipitation through the drainage network results in higher peak discharges and resultant increases in stream power (the left side of Lane's relation). Unstable channels may threaten stream crossings by eroding embankments or approaches, undermining piers, or destroying culvert foundations. As channels shift, the flow path of floodwaters may be directed at an unfavorable angle to structural piers and abutments. Piers originally founded in overbank floodplain areas can become main channel piers due to channel migration. Footings and foundations may be exposed and undermined by local scour or channel degradation. Concave banklines (outsides of meanders) typically migrate downvalley, and may impinge on approach embankments or abutments (Figure 9).

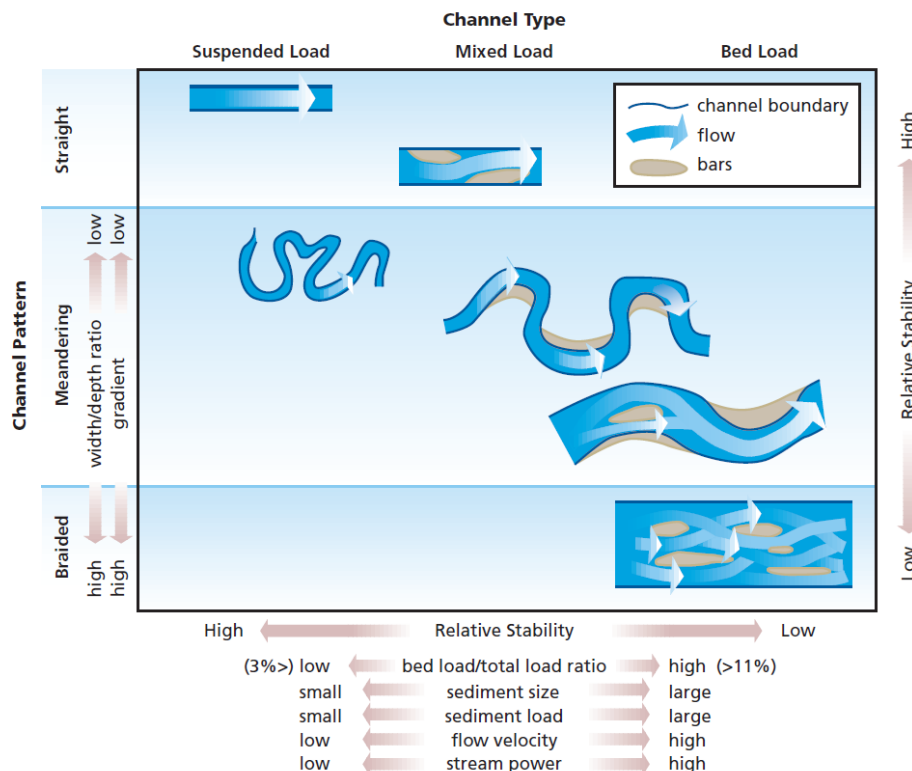
**Figure 10. Simple Stream Classification System**

The classification system proposed by Schumm categorizes river reaches based on pattern (planform) and sediment load.

Since the sensitivity of channel systems varies widely, several authors have attempted to classify their susceptibility to instability when subjected to hydromodification. The Schumm system shown in Figure 10 rates relative stability for various channel types; presumably, sensitivity to hydromodification is greatest for the most unstable types of channel. The U.S. Army Corps of Engineers (USACE) (1994) has classified stream types based on channel planform; this system offers the advantage of including engineered (channelized) systems (Table 2). In another example, Montgomery and Buffington (1997) classified stream channel reaches into seven categories based on the nature and organization of the bed material (Table 3). For five of these seven channel types that are single thread, alluvial channels, Montgomery and MacDonald (2002) tabulated the channels' sensitivity to an increase in water and sediment inputs (Table 4). They suggest that pool-riffle streams are the most sensitive to hydromodification. Pool-riffle channel dimensions (depth and width) and bank stability are very sensitive to changes in coarse sediment supply and to increases in discharge. Bed material in these channels is also very responsive to changes in sediment supply and water discharge. By comparison, cascade and step-pool channels are not as sensitive and will maintain their dimensions and bank stability despite changes in sediment and water supply.

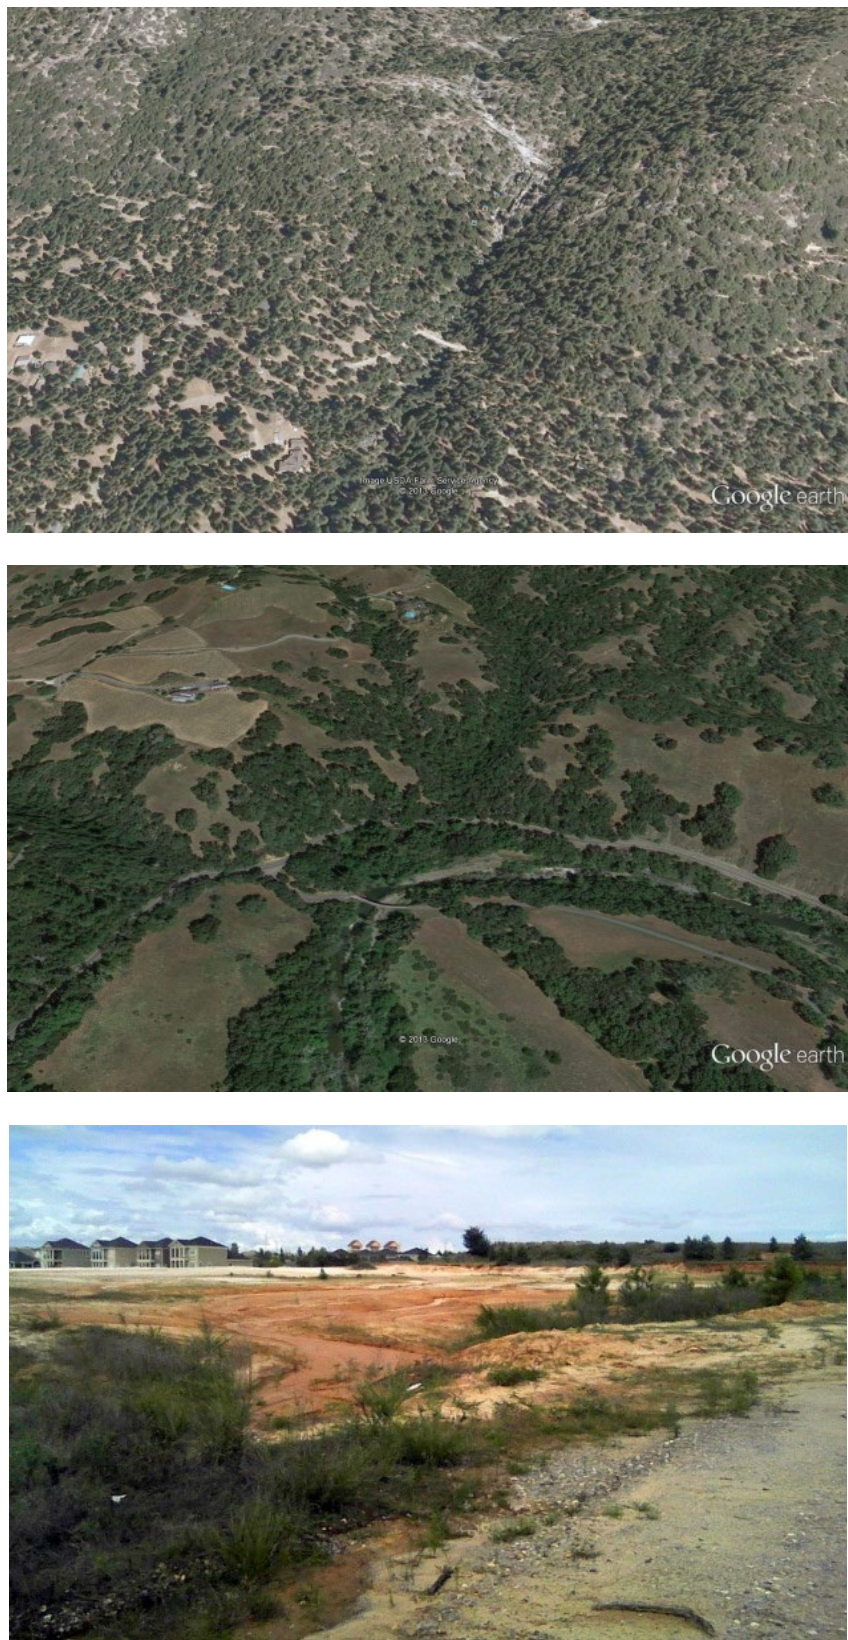
**Figure 12. Watershed Examples**

*From top: excellent, good to fair, and poor watershed and floodplain conditions*

The first indicator has to do with watershed land use. An Excellent rating is reserved for watersheds in pristine condition with natural climax vegetation. The land surface is generally undisturbed by roads, logging, mining, construction, or other types of disturbance. Higher scores are assigned based on the departure of the watershed from such ideal conditions, with emphasis on types of disturbance that produce hydromodification (Table 6). For example, higher scores are assigned to watersheds with steeper slopes, highly erodible soils, landslide potential, or disturbances that are expanding in scope, such as subdivision construction or expanding surface mines. A pristine watershed in Yosemite National Park, which would receive a score of 1 or 2 for this indicator, is shown in the top frame of Figure 12. The middle frame is a channel within the Russian River watershed. Although substantial amounts of forest cover are visible, much of the forest has been cleared and is now grassland. Furthermore, homes and a highway are visible. In order to assign a score for a reach in this area, the entire TDA should be evaluated, but the land use shown would indicate a score in the Good (4 to 6) or Fair (7 to 9) range. The lowest frame shows a watershed disturbed by large-scale grading and construction of condominiums. The ephemeral channel in the center of the frame is choked with sandy sediment. This watershed/floodplain condition would receive a Poor (10 to 12) score. See Example 1 in Appendix B for a case where this indicator received a low score due to a very nonurban setting.

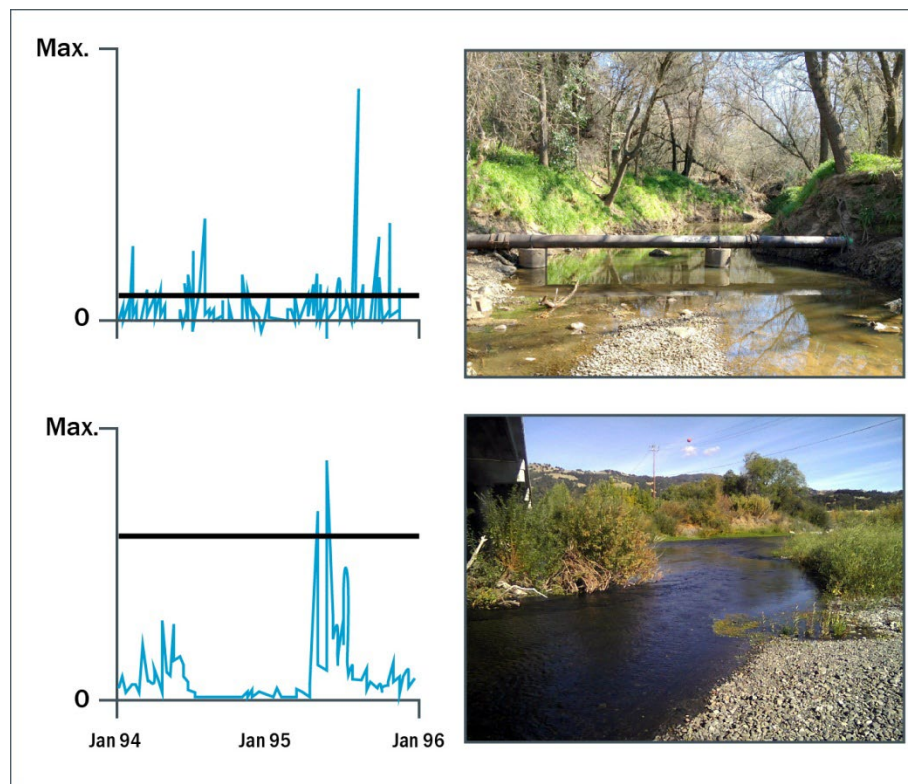
**Figure 13. Flow Characteristic Examples**

*Flashy discharge hydrograph from incised channel in urban area (Top Plot), and hydrograph of perennial stream draining natural area fed by snowmelt, with no flashy behavior (Bottom Plot). Horizontal lines indicate discharge levels that transport the most sediment. Photos to the right of each plot illustrate typical conditions for flashy and stable-flow channels, but are not from the same locations as the hydrographs.*

The second indicator is a measure of stream flow variability when viewed across a year or longer period (Figure 13). Hydromodification tends to reduce the percentage of stream flow that is contributed by shallow groundwater and increase the amount of direct runoff. Accordingly, ephemeral, flashy (rapid rise and fall) hydrographs are given higher (less stable) ratings. Since the field inspection portion of the RSA is typically a one-time event at baseflow, this indicator is best assessed using actual gage data, obtained as described in the section below on Level 2 analysis. In the absence of such data, flow characteristics may be roughly assessed based on the appearance of the channel and its environs when the field inspection is conducted. Channels with stable, perennial flows and no flashy behavior (Table 6) tend to have well-defined, densely vegetated banks.

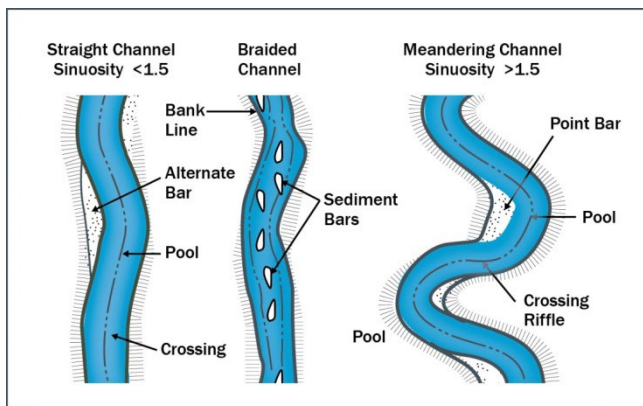
**Figure 14. Plan View of Major Channel Patterns**

*Note that the threshold given in the figure between straight and meandering ( $P = 1.5$ ) is slightly different than the one used herein ( $P = 1.25$ ).*

The third indicator, channel pattern, refers to the planform, or the way the channel appears from above (Figure 14). A wide range of meandering and braided channel patterns have been identified (USACE 1994, Figure 2-11), but herein we classify channels simply as straight, meandering, or braided. A straight channel has roughly parallel top banks, with no major bars evident at baseflow. Note that artificially straightened, channelized, or engineered channels (Table 6) are rated separately from straight channels. A meandering channel has a single thread at baseflow that follows a sinuous course. Typically, the degree of sinuosity is quantified by the ratio of the distance measured along the channel centerline by the straight line distance between the same two points: sinuosity,  $P = \text{channel length}/\text{valley length}$ , as shown in Figure 15. The example shown in Figure 15 has a sinuosity of 1.22, which places it on the borderline between straight and meandering and would produce a low (Excellent) score for this indicator. A score of 1 would be reserved for a perfectly straight channel or one with very smooth bends; the presence of two moderate bends in the reach would elevate the score to 3 or possibly 4. Fully meandering channels receive ratings of Good (4 to 6) or Fair (7 to 9) based on channel pattern and sediment load type. Bank stability, radius of bend curvature, and presence of bars are indicators of sediment load type, as shown in Figure 10. Braided channels have multiple interlacing flow threads, and are typically unstable and quite sensitive to hydromodification. Accordingly, braided channels receive Poor (10 to 12) ratings for this indicator. Channels with braided patterns that have flow threads separated by stable, well-vegetated islands are sometimes called anastomosing channels, and may be assigned Good or Fair ratings if they appear to be quite stable. Engineered channels may be rated Good, Fair, or Poor depending on evidence of bed or bank erosion, bank vegetation, and debris accumulations, with well-maintained channels receiving the lowest scores and Good to Excellent ratings. Example 3 in Appendix B is based on an engineered channel that alternates between braiding and single thread meanders based on the water surface elevation and the location along the reach. Scores for individual cross sections varied from 3 to 9, and the site received an overall average score of 5.8.

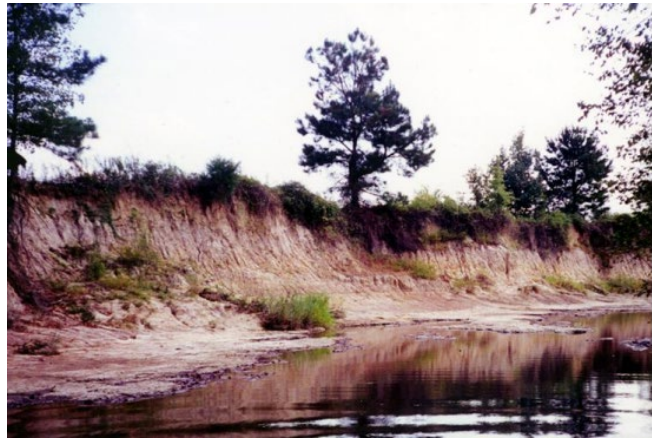
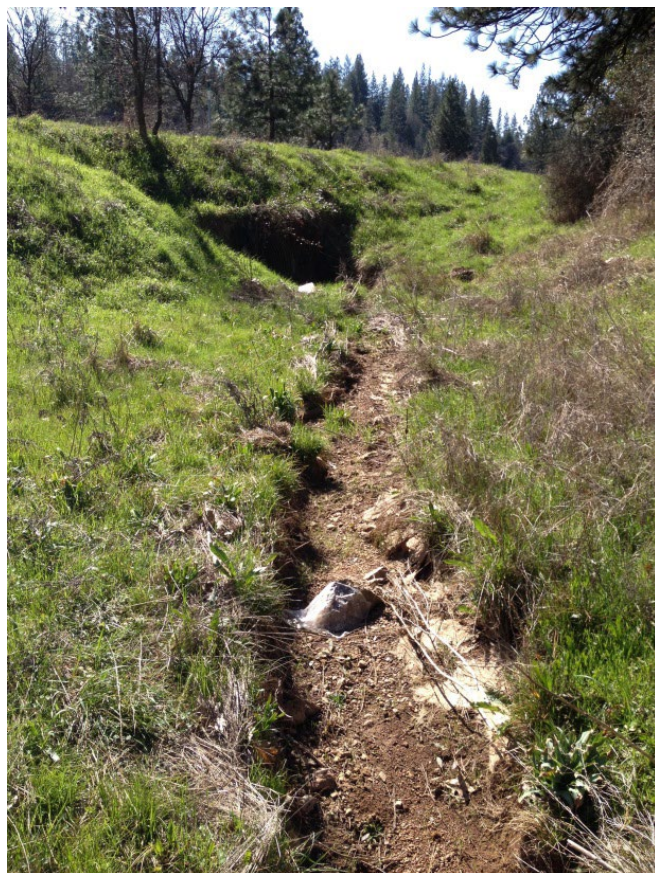
**Figure 17. Channel Entrenchment Examples**

*Top:* Deeply incised channel with cohesive banks and lacking any sediments in channel bed. *Bottom:* Non-incised channel with berms or floodplains several times as wide as the channel on both sides. No signs of undercutting infrastructure or oversteepened banks.

- No bars or sediment deposits— erosion of the channel bed down to bedrock or other resistant soil layer. Sometimes banks on both sides of the channel will be near vertical, raw, and eroding (Figure 17).

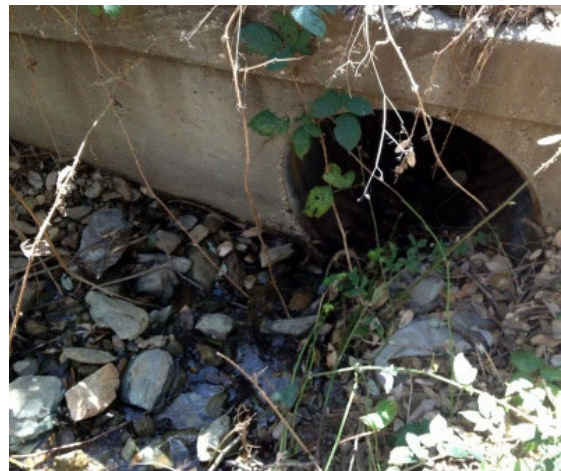
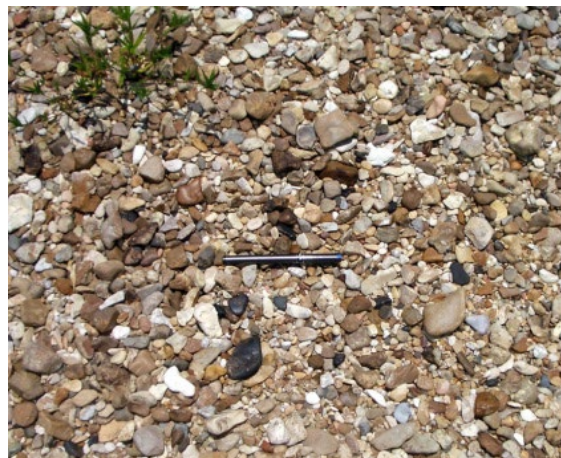
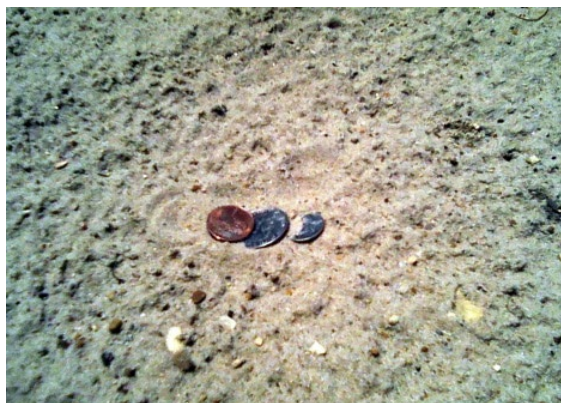
**Figure 18. Examples of Bed Material**

*Top:* Excellent bed material. Large gravel and cobble, tightly packed. *Middle:* Good bed material. Writing pen in center for scale. Bed is covered with 10–30 mm (0.4 – 1.2 in.) gravel at this point, but sand appears elsewhere along the cross section (outside the photo). Sediments are only slightly imbricated (overlapped and packed). *Bottom:* Poor bed material. Coins for scale. 90% sand,  $D_{50} \sim .20$  mm.

The fifth indicator, bed material, is based on the size of bed sediments and how tightly they are consolidated or interlocked (Figure 18). Table 6 uses the variable  $F_s$ , or the fraction of the bed composed of sand, as a key discriminant for this indicator. Strictly speaking, if sand-sized sediment is present on the bed in mixture with other sizes, a sample must be collected and subjected to sieve analysis to generate reliable estimates of  $F_s$ . However, for the purposes of an RSA, a simple visual estimate of the fraction of bed surface that is sand is adequate. The engineer should examine the channel from the top bank where it affords an unobstructed view of the bed, or from near the channel centerline, to make this estimate. Each estimate should apply to a given cross section, and an overall average should be determined based on at least 10 cross sections placed at constant spacing along the  $\geq 40W$ -long representative reach.

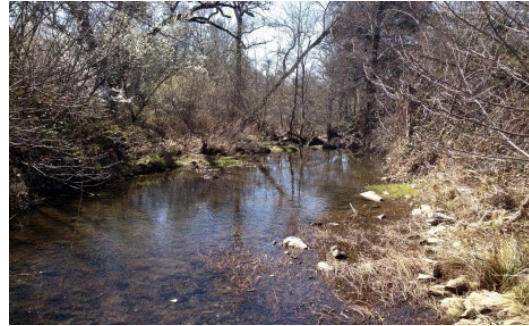
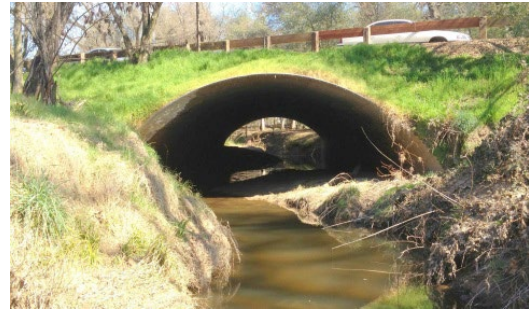
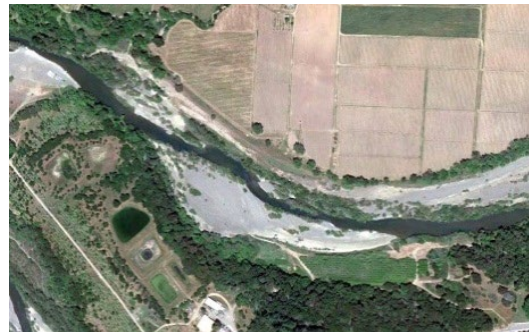
**Figure 19. Examples of Bar Development**

*All sites have slopes < 0.02 ft/ft and W/D > 12.*

Bar development is the sixth stability indicator. Bars, their sediment size, and their vegetation, as described in Table 6, are diagnostic of relative stability (Figure 19). Channels with greatest sensitivity to hydromodification are likely to have large bars composed of sandy sediments with minimal vegetation. It should be noted that bar vegetation can reflect antecedent flow and weather conditions as much as channel stability. Even unstable channel bars may be heavily colonized during droughts by invasive herbaceous species, which will only be washed away during the next high flow.

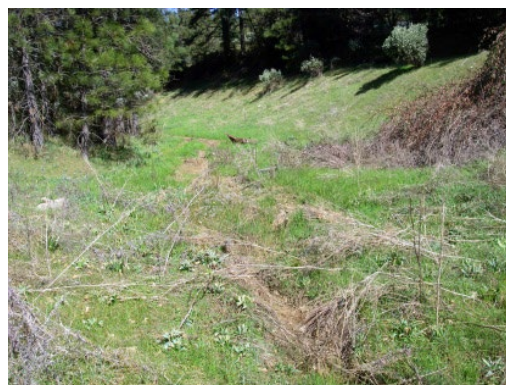
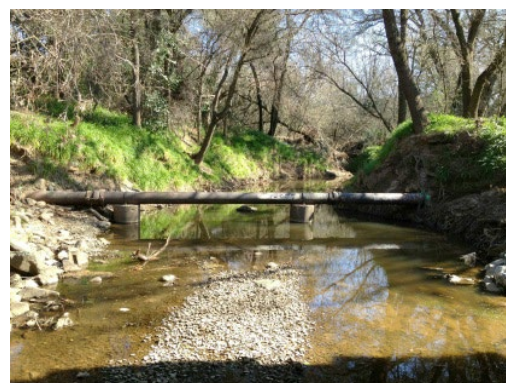
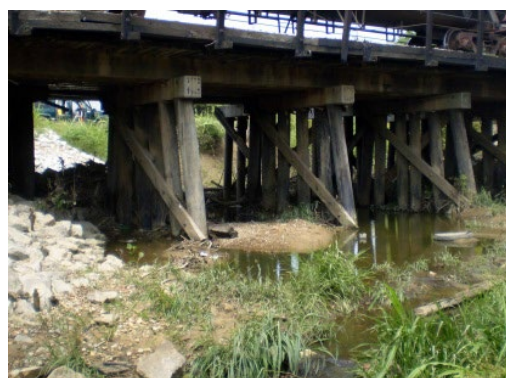
**Figure 20. Examples of Obstructions**

**Top:** Excellent condition for obstruction. Small amounts of vegetation and one piece of metal debris in approach channel to culvert. **Middle:** Good obstruction. Pipeline crossing (with concrete piers) is only major obstruction in reach, but local deposition and scour caused by obstruction are evident. **Bottom:** Poor obstruction condition. Railroad bridge crosses channel at an angle so that pile bents are oriented at an angle to approach flow, collecting debris and trash and impacting entire reach. Riprap bank protection and vegetation add minor obstruction. Sediment accumulation downstream from obstruction is evident.

This indicator is based on the presence or absence of solid objects that obstruct higher flows (flows approaching bankfull). Examples of flow obstructions include large wood formations, bedrock outcrops, river training dikes, spurs, vanes, barbs or groins, beaver dams, grade control structures or weirs, water intakes or outfalls that project into the flow, and human-made objects such as junked cars (Figure 20). Riprap revetment or bed armor constitutes a minor flow obstruction. Although natural stable channels often feature large wood or rock obstructions that stabilize local sediment deposits and maintain channel alignment, an Excellent rating for this indicator requires that obstructions of all types be rare or absent. Obstructions can deflect flows and promote local scour, particularly if peak flow rates increase. Furthermore, some types of obstructions (such as large wood accumulations) are indicative of upstream erosion. Higher scores for this indicator are warranted when obstructions are associated with in-channel erosion and deposition, and especially when associated with changes in channel alignment. Channels that carry high loads of large wood should receive higher scores for this indicator as the potential for formation of obstructions—either jams in the channel or large wood accumulations on the crossing structure—is significant. Additional detail on forecasting debris loading for highway structures is provided

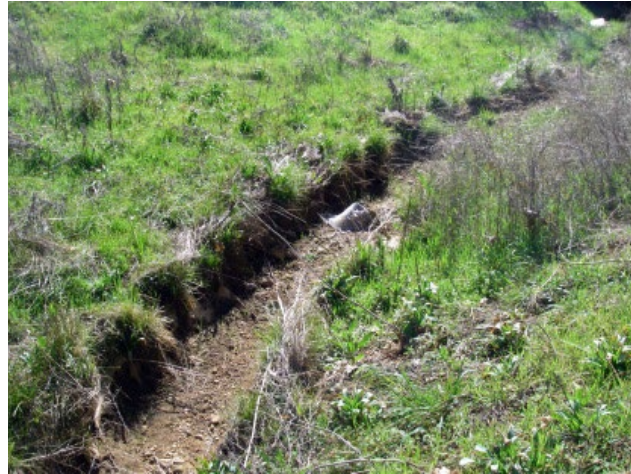
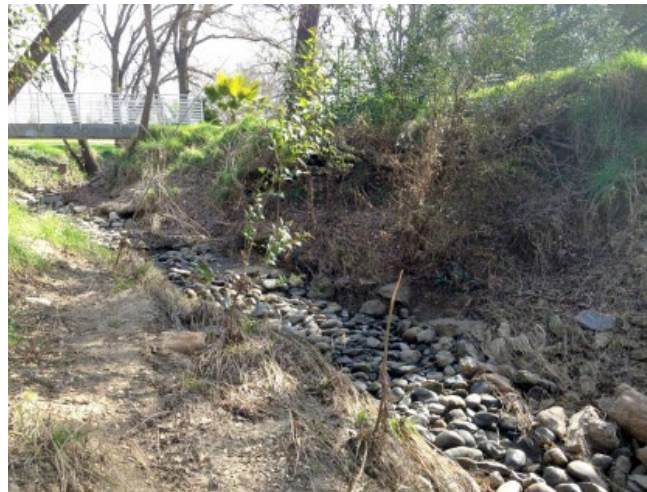
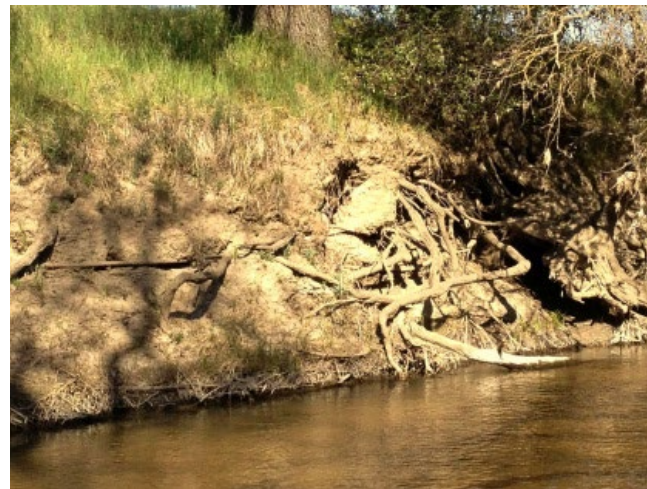
**Figure 21. Examples of Bank Slope Angle**

*Top:* Excellent score. Average bank slope is 5H:1V, cohesive soils, bank heights ~ 6 ft.

Stream banks may erode as individual grains or aggregates of soil are removed by water flowing past the bank, or they may fail as large blocks of soil break free and tumble into the channel (mass failure). Bank resistance to mass failure is directly related to soil shear strength and inversely related to bank height and angle. Higher, steeper banks are less stable. Accordingly, scores for this indicator are higher for steeper banks. However, bank angle is not important for very low banks, and even steep banks may be assigned low numerical scores if the bank height is less than about 2 ft. Bank angles should be measured at several cross sections and averaged, but banks may be omitted if they are fronted with large bars reaching half of bank height or more. Angles may be visually estimated, measured from survey cross sections, or measured in the field using a Brunton compass or equivalent. Stability ratings vary with bank soils, as noted in Table 6 and Table 7 (Figure 21). When ratings are different for left and right banks, the higher of the two scores should be recorded. Example 3 is an urban, channelized stream with rather steep banks that received a score of 10 for this indicator.

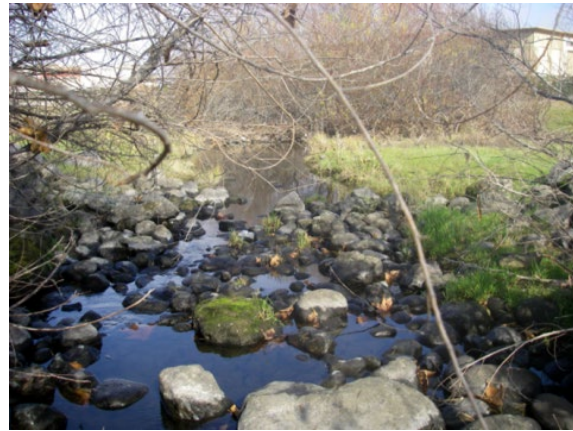
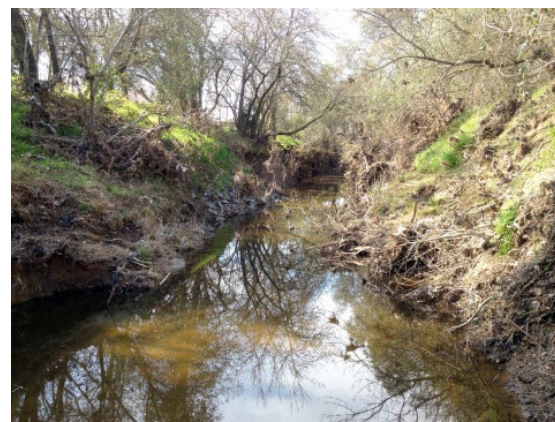
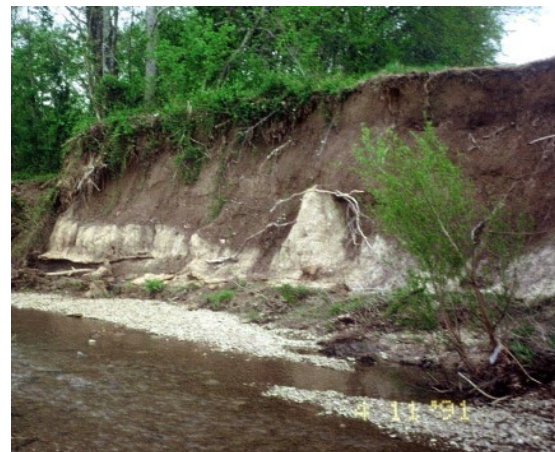
**Figure 22. Bank Protection Example**

**Top:** Good score for vegetative or engineered bank protection indicator due to bank stability, partial coverage of banks by woody species, and partial protection of bank with stone. **Middle:** Fair bank protection. Small band of woody vegetation at top of bank. Trees leaning over channel, root exposures, some riprap at toe of left bank. **Bottom:** Poor bank protection. Very little woody vegetation along banks, no structural lining or armor.

Stable, well-protected banks are less susceptible to erosion due to hydromodification than those already exhibiting signs of stress. Bank protection may consist of artificial structures, such as riprap revetment, or a band of dense, healthy riparian vegetation (Figure 22). Excellent scores are reserved for sites with either (1) both banks protected by intact revetment or lining (asphalt or concrete) or (2) both banks heavily vegetated with erect, mature hardwoods. Departures from these conditions warrant higher numerical scores (Table 6). Scores for this indicator should be determined by examining at least 10 cross sections placed at constant spacing along the >40W-long reach. If vegetation is present, attention should be paid to signs of distress, such as exposure of roots and the orientation of trunks with respect to vertical. Higher scores are assigned to softwoods, coniferous species, and monocultures. In similar fashion, higher scores should be assigned to banks with damaged revetment or other damaged countermeasures. Refer to Example 4 in Appendix B for a case where an overall score of 7.7 was assigned to an urban channel without any engineered bank protection, but a thin but fairly dense band of trees growing at the top of both banks.

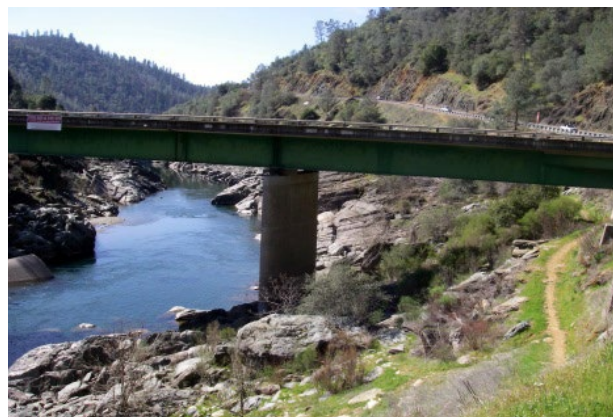
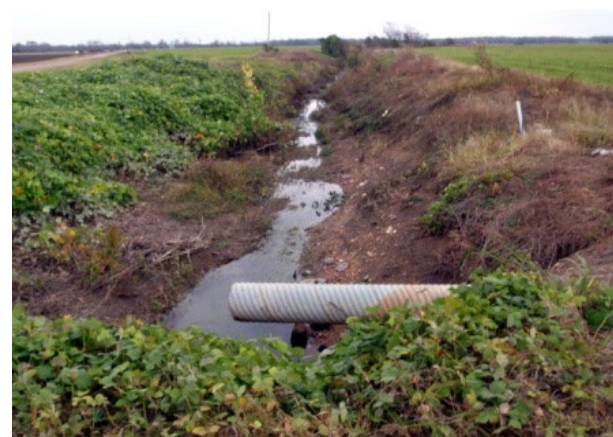
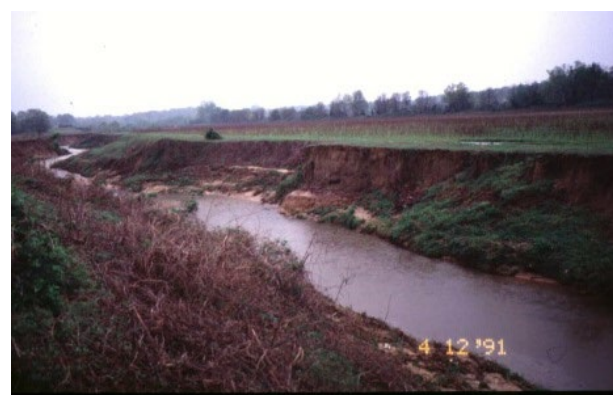
**Figure 23. Bank Erosion Examples**

*Top:* Excellent score. Bank erosion limited to insignificant footpath along upper bank due to bedrock and boulders along lower bank. *Middle:* Good score. Raw area is prominent on right bank, but there are no undercut roots, and much of the bank is well vegetated with herbaceous species. *Bottom:* Poor score. Almost continuous exposed soil and cuts along both banks.

Bank erosion is rated based on its extent along the reach and its severity (Figure 23). Streambank erosion is a natural process, and alluvial channels will exhibit raw (unvegetated) banks in certain locations, especially at elevations below normal baseflow and on the outside of bends. However, when bank condition is assessed for an entire >40W-long reach, stable channels that receive Excellent ratings for bank erosion will exhibit only small areas of active erosion. Poor ratings are associated with near-continuous raw banks, both in a streamwise direction and up and down the bank at a given cross section. Bank vegetation can be a strong indicator of rapid erosion, the engineer should look for undercut root mats and sod. Especially notable are local zones of distress, such
