**Caltrans Hydromodification/Stream Channel Stability  
Requirements Guidance  
*Storm Water Best Management Practices  
Rapid Assessment of Stream Crossings  
Higher Level Stream Stability Analysis***

**November 2023**

**California Department of Transportation  
1120 N Street  
Sacramento, California 95814**

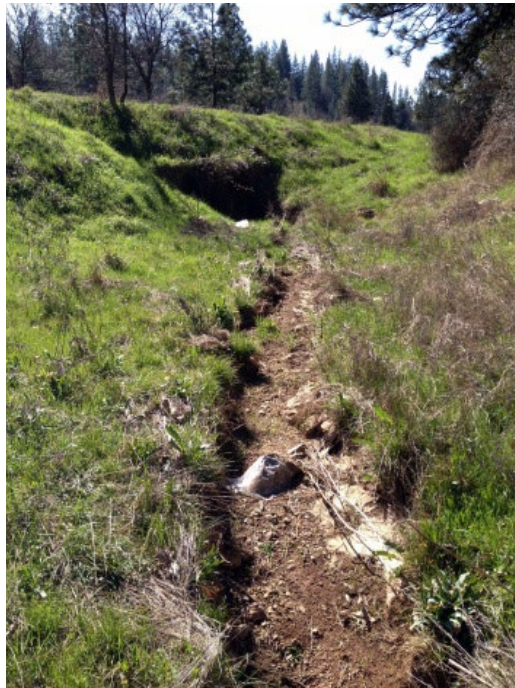
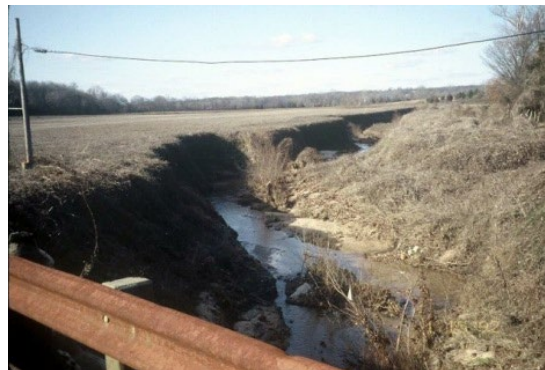
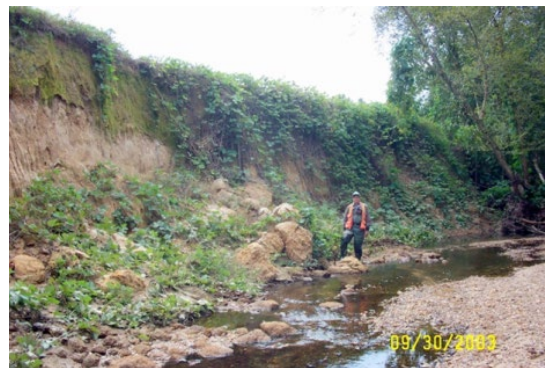
**Figure 24. Examples of Mass Wasting or Bank Failure**

**Top:** Excellent score. Low, well-vegetated banks with no evidence of mass failure. **Middle:** Fair score. Evidence of frequent and significant mass wasting. Channel width irregular, scalloping of left bank. Presence of bank vegetation slightly reduces score. **Bottom:** Poor score for mass wasting indicator. High banks with recent failure blocks at toe, regular bank slumping, irregular channel width (not visible from this photo point).

In contrast to the bank erosion described by the previous indicator, mass wasting or bank failure is indicated by the removal of large blocks of material from the bank face (Figure 6 and Figure 24). Mass wasting may occur when portions of the bank are undercut by toe erosion, when banks become so high and steep that they slump or slide, or when subterranean erosion by shallow groundwater works in concert with other processes to weaken a large section of bank that then slumps, caves, or slides. Banks experiencing mass wasting are typically high and steep and composed at least in part of cohesive soils; also, failure blocks are often present along the toe of bank. These failure blocks gradually disintegrate through cycles of wetting and drying, and the resulting smaller particles are removed by high flows. Leaning or fallen trees along the bank are often indicative of mass wasting; in some cases failure blocks may rotate back toward the bank as they fall, causing trees to lean away from rather than toward the channel. Sandy banks do not produce failure blocks, but can experience mass wasting as shallow, planar slides of material when bank toes are undercut. Mass wasting can be a rapid process. Usually banks subject to mass wasting have tension cracks along the top bank that run parallel to the channel 1–3 ft from the bank face. Because mass failures do not occur simultaneously all along a given channel, banks subject to mass wasting often display a scalloped appearance, giving rise to variable top bank widths. Example 2 in Appendix B is an ephemeral, desert wash with unstable banks that exhibited mass wasting in the form of shallow, planar slides.

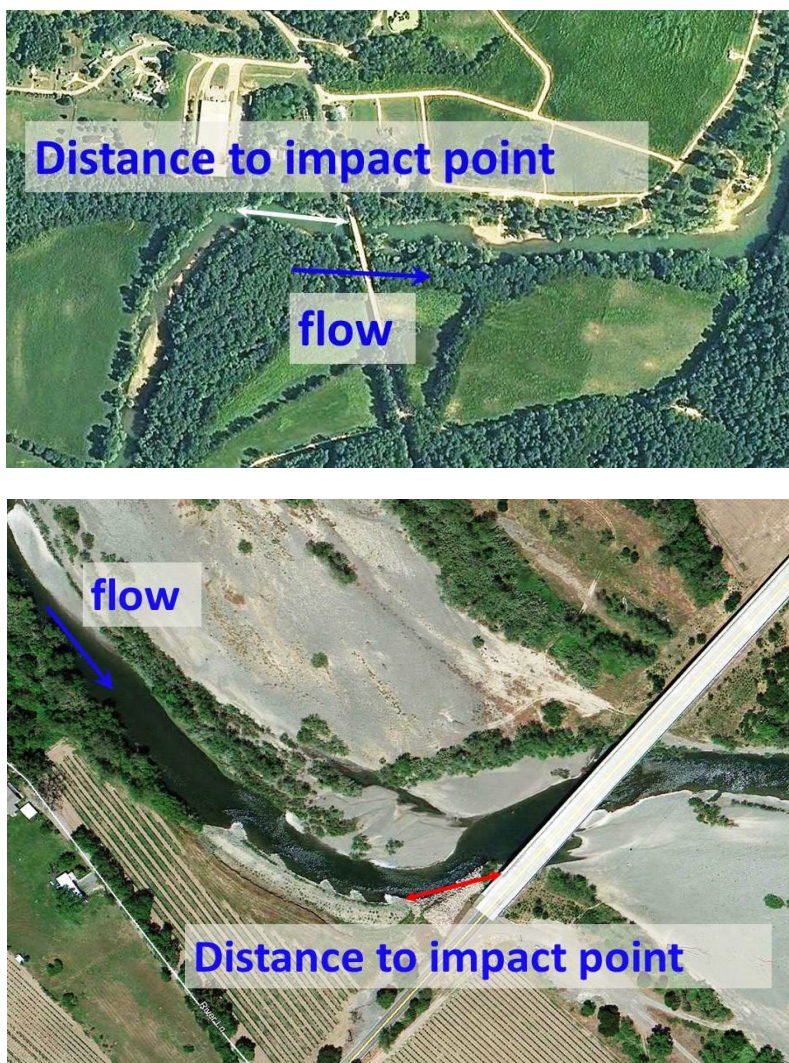
**Figure 25. Stream Crossing Alignment with Flow Examples**

*Distance to impact point is measured starting at the upstream end of crossing and moving upstream to the point of greatest erosional stress on the bank of the first bend.*

Most stream channels are not straight, and flow forces on banks are typically greatest just downstream of the apex of a bend, at a point that coincides with the intersection of flow lines or the channel centerline at the bend entrance and the bankline (Figure 25). This point is called the meander impact point, and often corresponds with a zone of rapid bank migration. Meander migration typically occurs in a downvalley direction, so the proximity of upstream impact points to stream crossings is of concern in the RSA. Rapidly migrating bends can impinge on embankments or approaches to bridges or culverts. Tight bends upstream of crossings will produce poor alignments, such that flow must turn sharply to pass through the crossing. Ideally, flow should be aligned so that high-flow vectors pass directly through the bridge or culvert with no redirection or deflection required. The examples presented in Appendix B generated low scores when upstream impact point locations were considered. However, Example 2 presented a complex case of stream channel flow alignment: “although the top bank alignment upstream from the bridge was well aligned, there was a small gully that joined the main channel immediately upstream from the bridge that made a sharp angle with the main channel and a large bar at the confluence of the two channels. A score of 9 was assigned to this indicator.

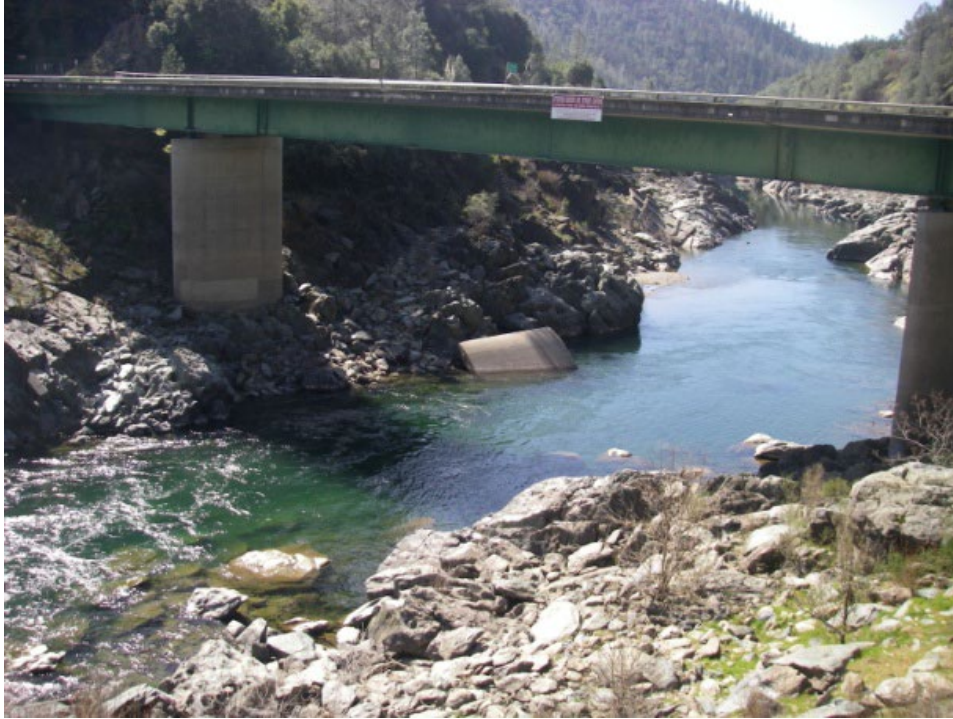
Figure B1.1. Placer-49, PM 0.2. Bridge over North Fork American River.

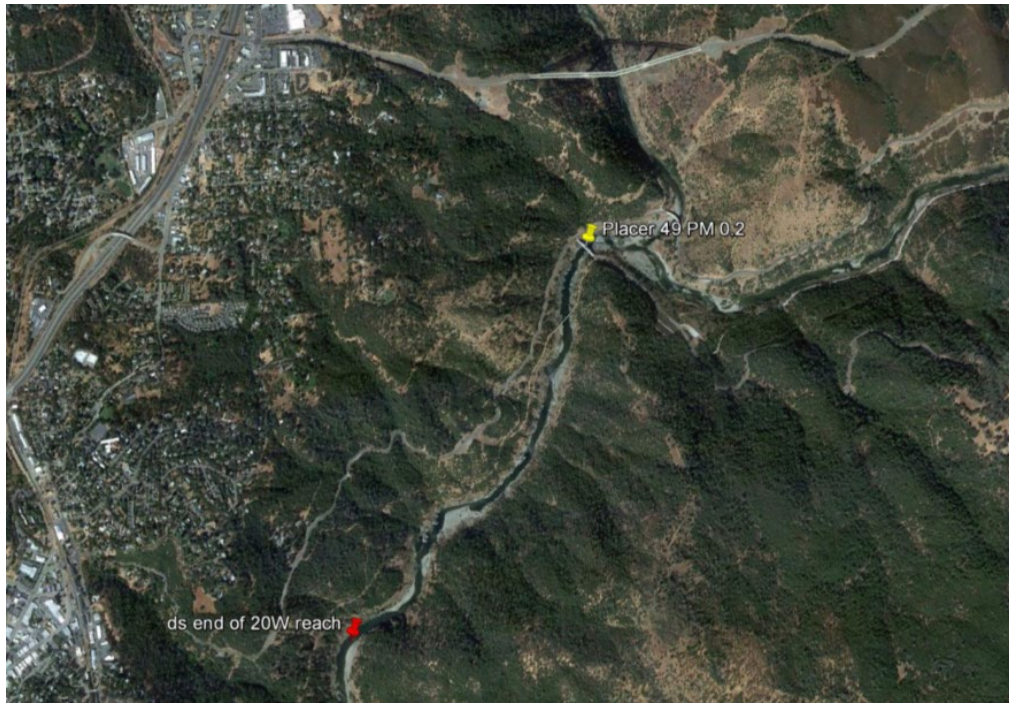
Figure B1.3. Location of point for delineation of threshold drainage area.

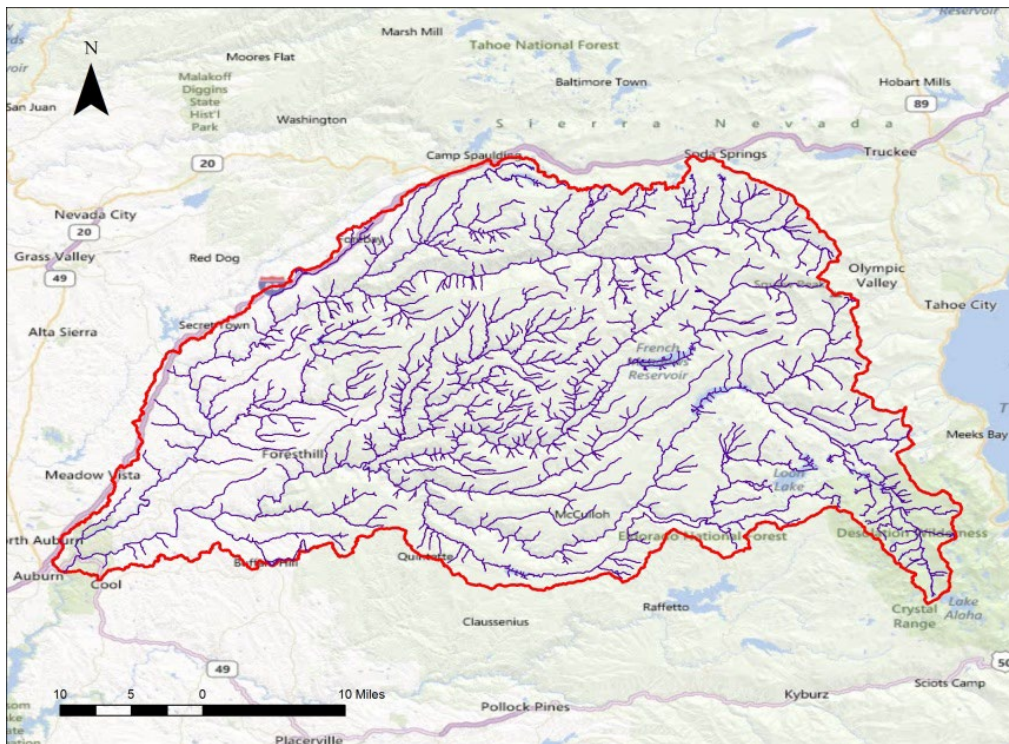
Figure B1.4. Threshold drainage area, Example 1.

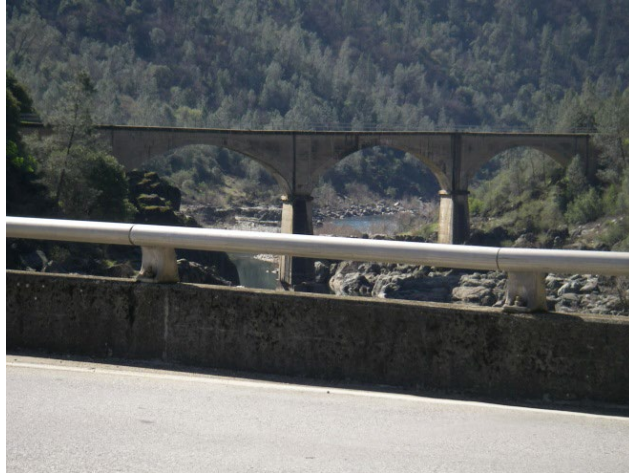
Figure B1.7. View upstream from Placer 49, PM 0.2 bridge showing channel confinement by narrow valley and downstream bridge.

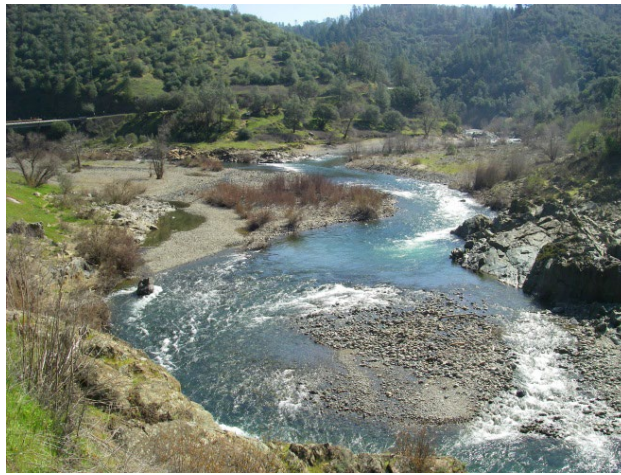
Figure B1.8. View upstream from the bridge showing typical bed material. Also see Figure B1.1.

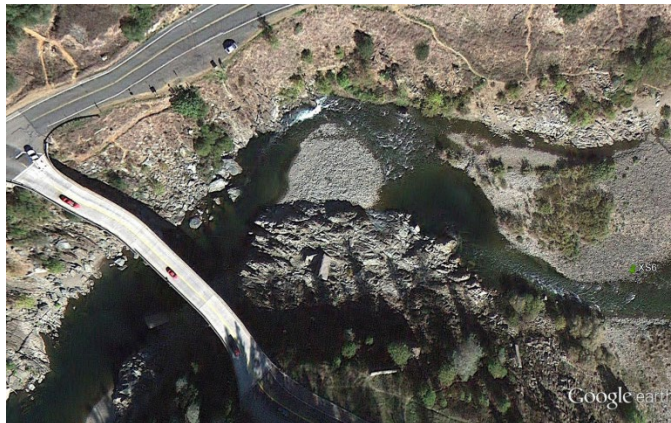
Figure B1.9. Measurement of distance from stream crossing to upstream impact point.

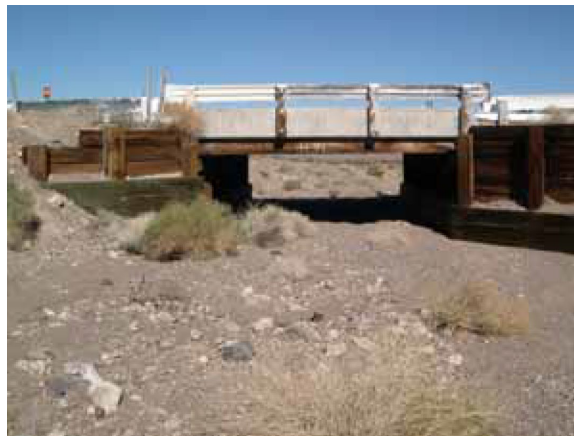
Figure B2.1. Route 66 crossing over unnamed Wash 3.5 miles east of Ludlow, California. Looking downstream. From Johnson (2006).

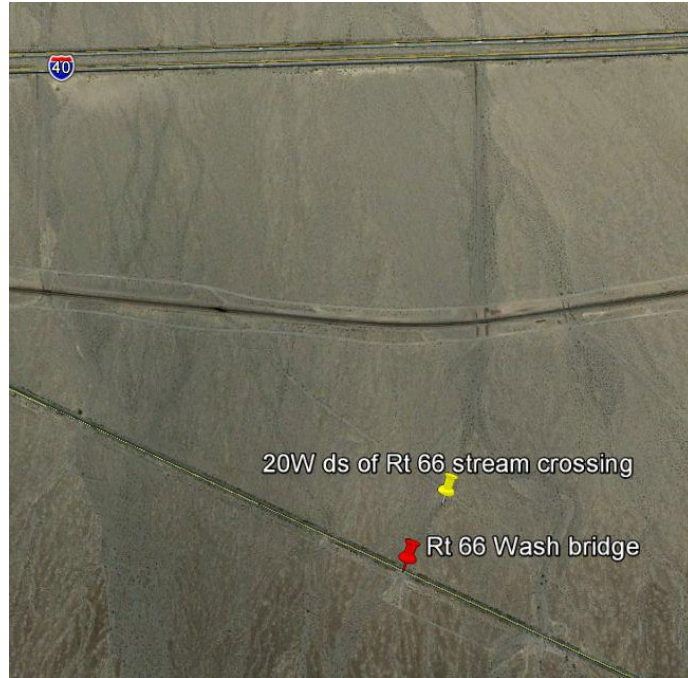
Figure B2.3. Location of point for delineation of threshold drainage area.

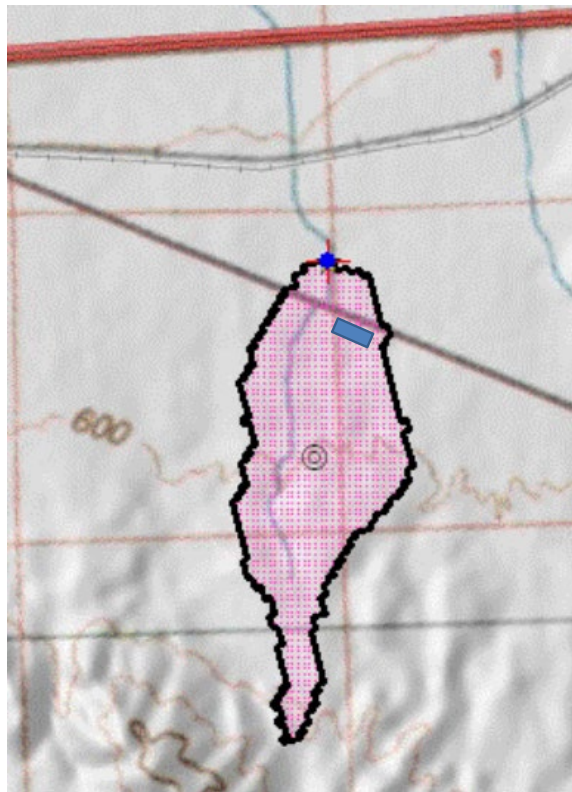
Figure B2.4. Threshold drainage area, Example 2. Gray rectangle indicates new impervious area.

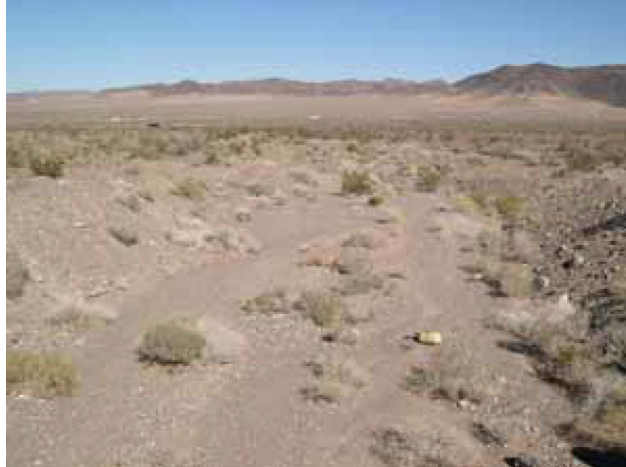
Figure B2.7. View downstream from Route 66 bridge showing lack of channel confinement and broad, flat floodplains. From Johnson (2006).

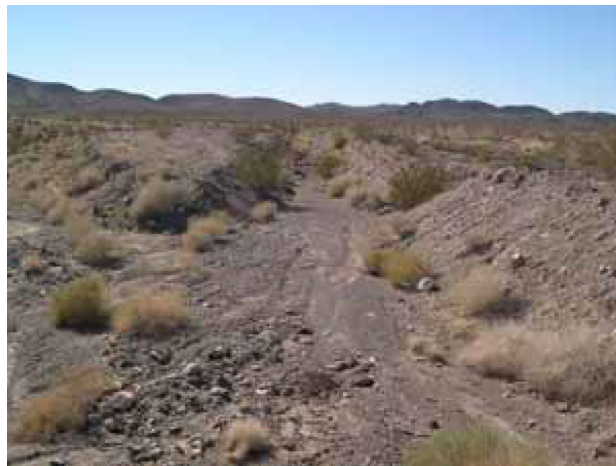
Figure B2.8. View upstream from the bridge showing typical bed material. Also see Figure B2.1. From Johnson (2006).

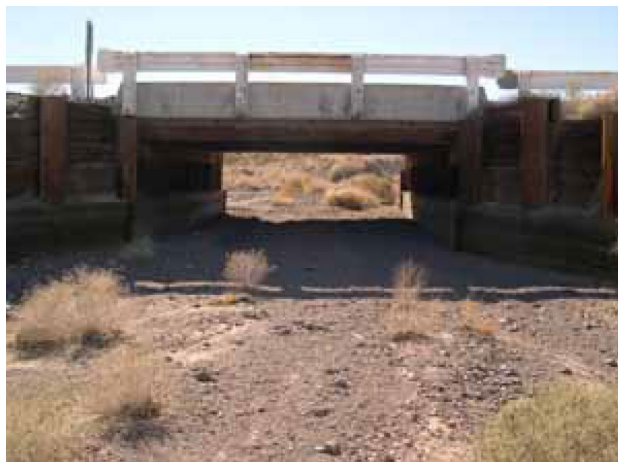
Figure B2.9. Route 66 crossing over unnamed wash 3.5 miles east of Ludlow, California. Looking upstream. From Johnson (2006).

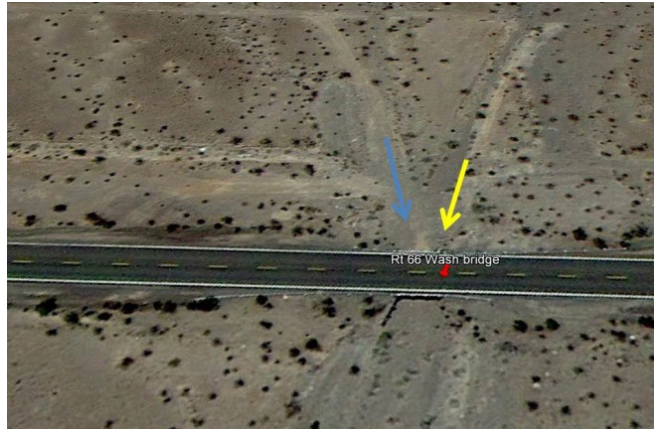
Figure B2.10. Stream crossing alignment with upstream flow in main channel (yellow arrow) complicated by tributary gully (blue arrow), unnamed wash 3.5 miles east of Ludlow, California. Looking upstream.

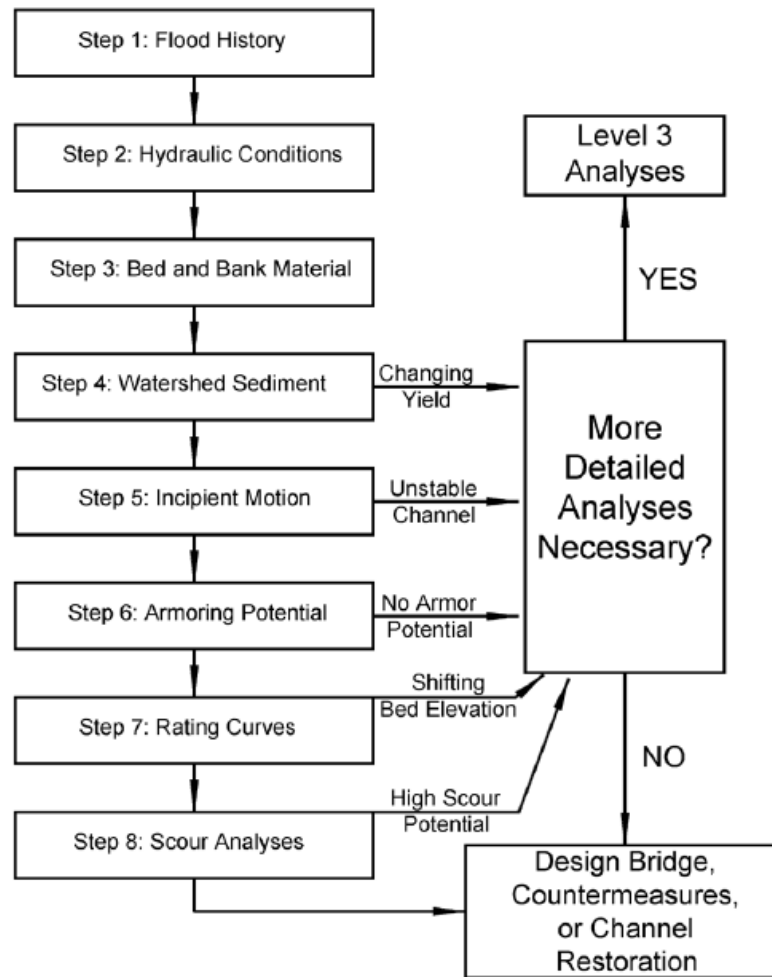
Figure B2.11. Flow chart for Level 2: Basic Engineering Analysis. From Lagasse et al. (2012)

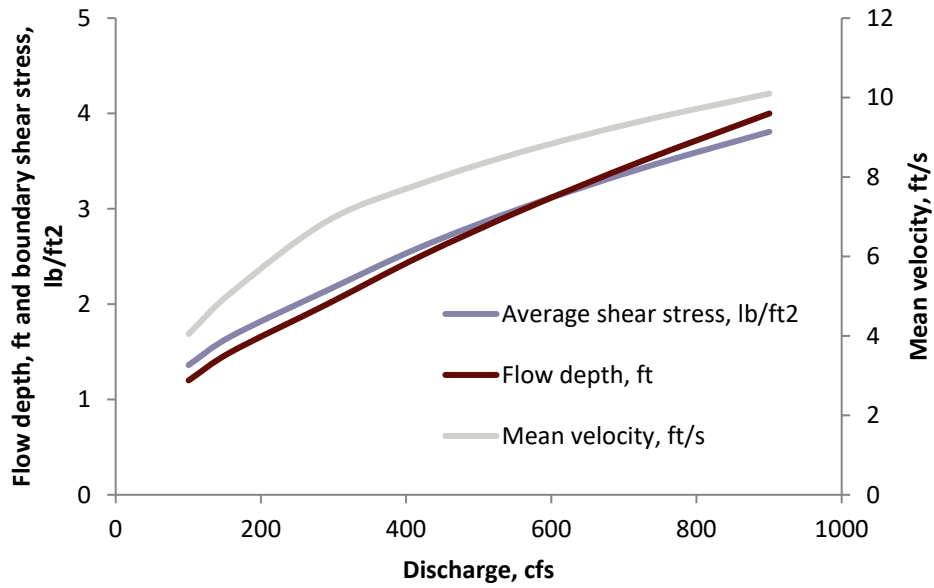
Figure B2.12. Hydraulic characteristics of representative reach, Route 66 Wash near Ludlow, based on assumption of uniform flow.

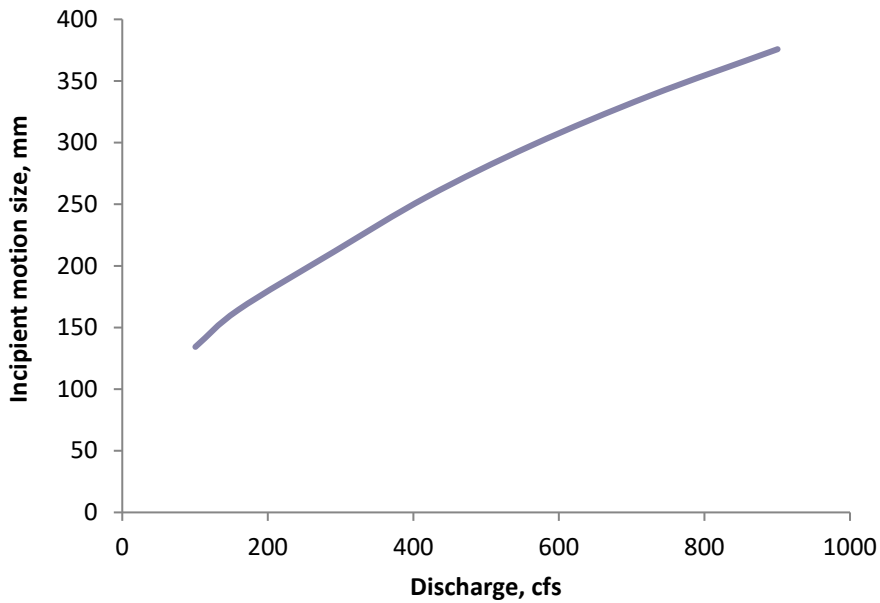
Figure B2.13. Incipient motion size for representative reach, Route 66 Wash near Ludlow.

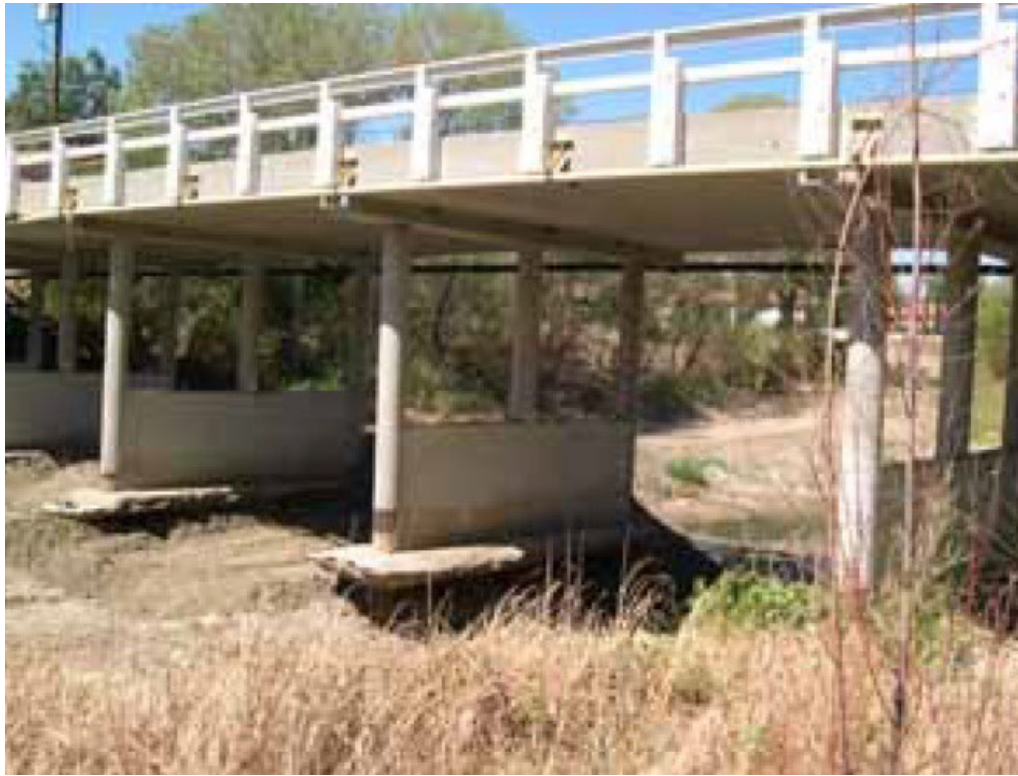
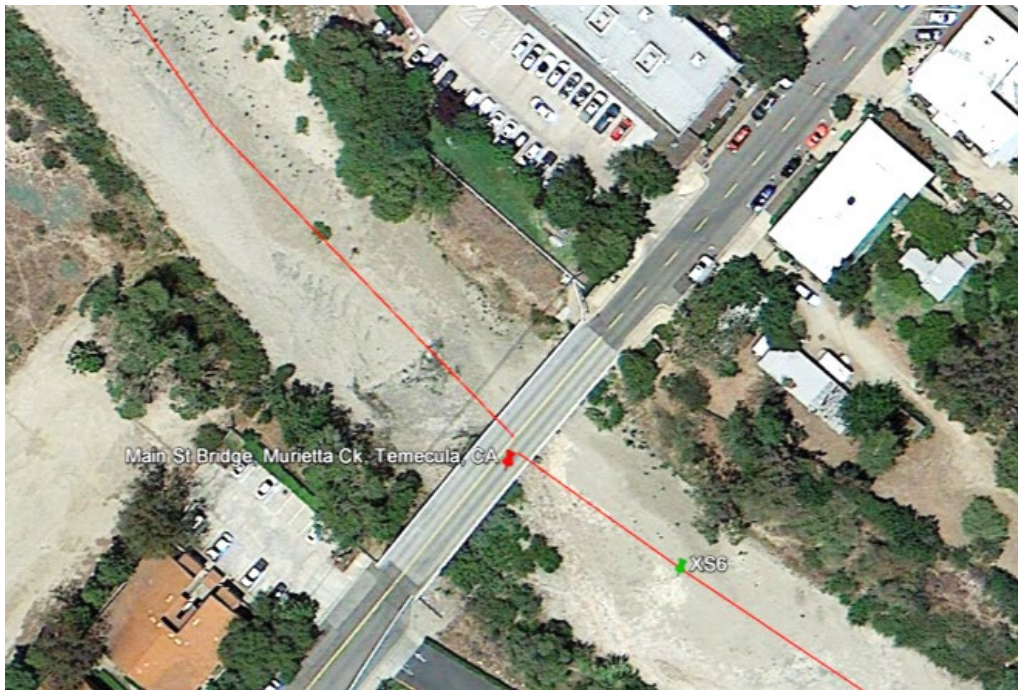
Figure B3.1. Ground level (top) and aerial (bottom) views of Main Street Bridge over Murietta Creek at Temecula, CA.

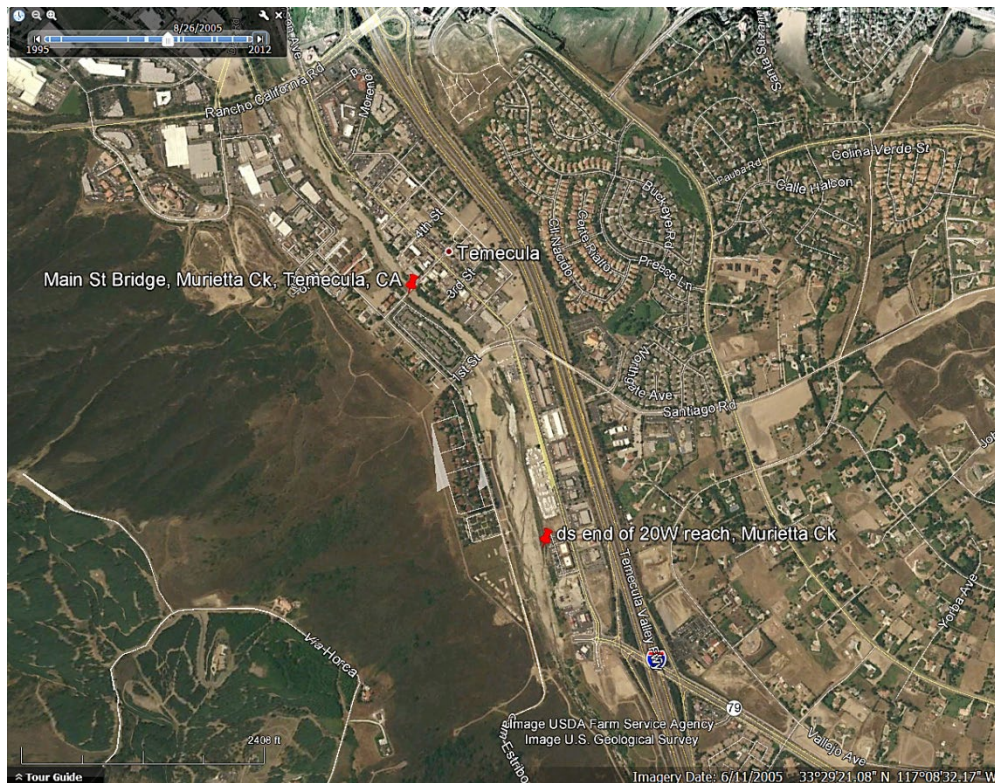
Figure B3.3. Location of point for delineation of threshold drainage area.

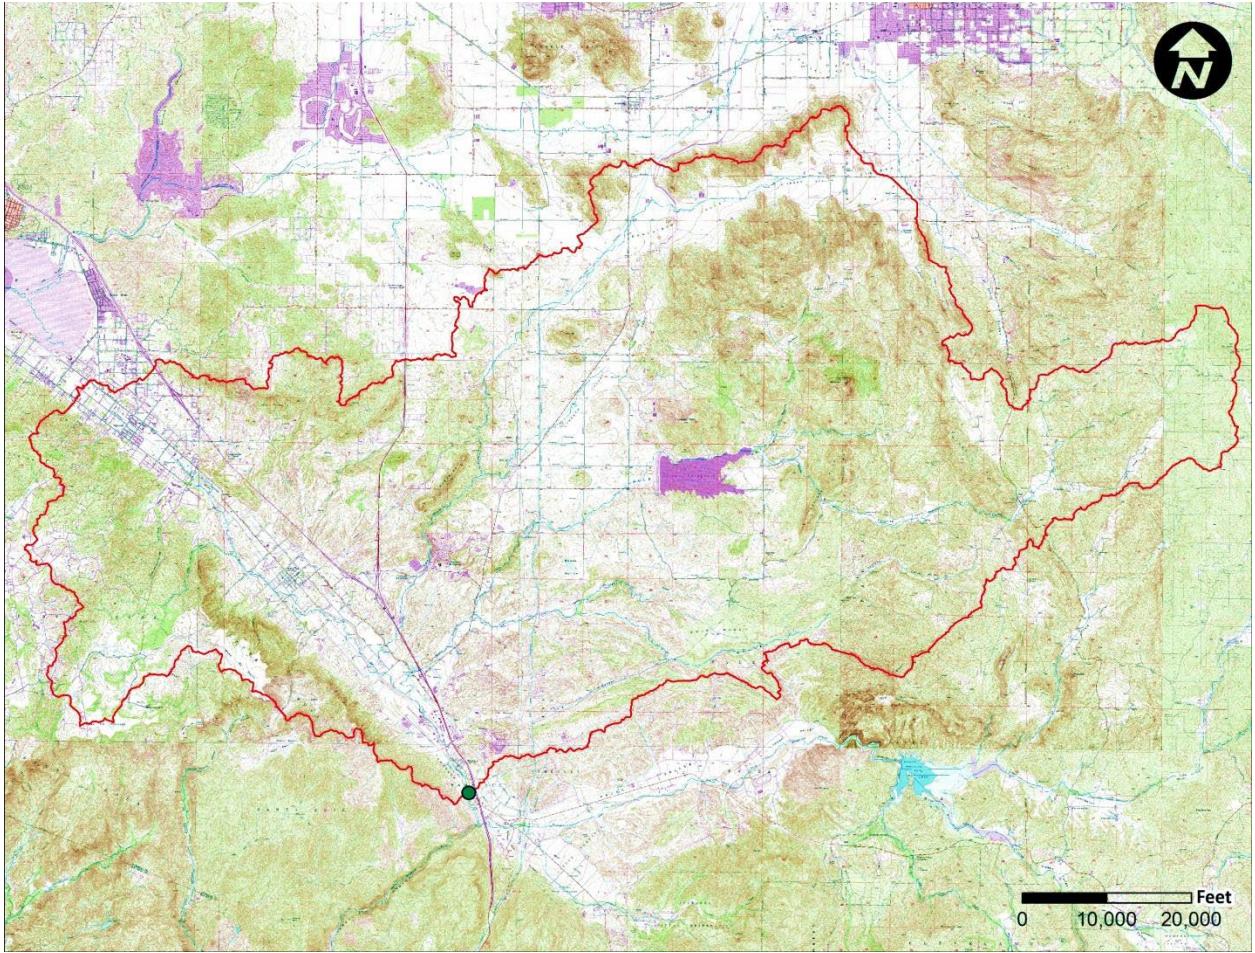
Figure B3.4. Threshold drainage area, Example 3.

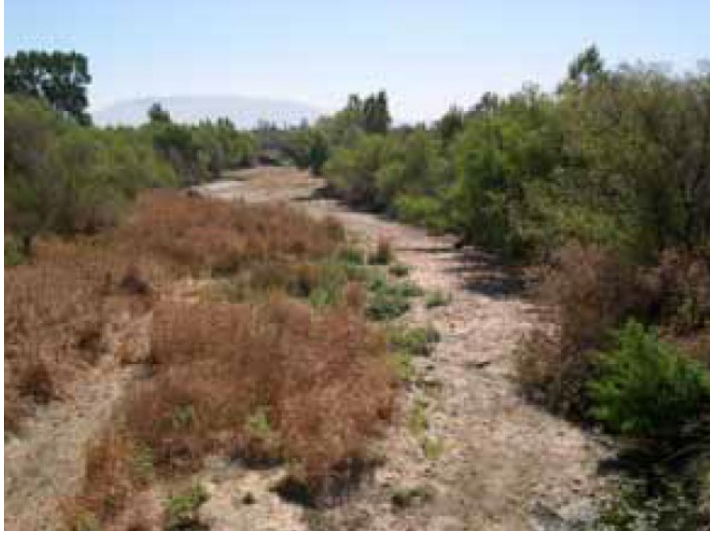
Figure B3.7. View from Main Street bridge facing downstream showing heavily vegetated alternate bars.

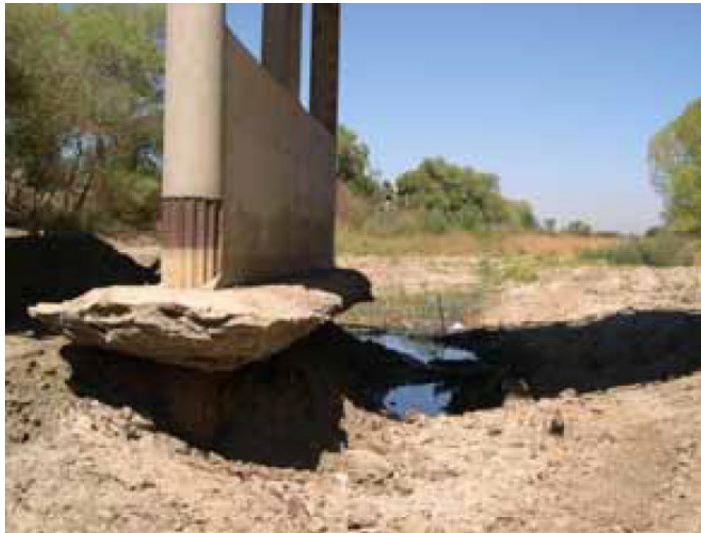
Figure B3.8. Main Street bridge showing exposure of bridge pier foundation due to bed lowering.

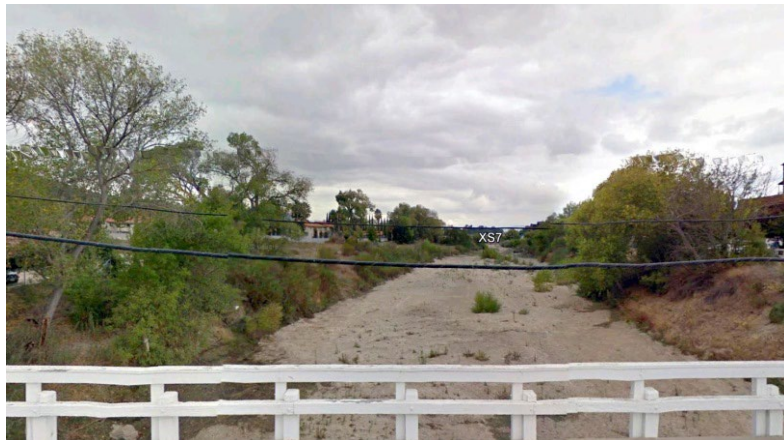
Figure B3.9. View upstream from the Main Street bridge showing typical bed material. Also see Figure B3.1.

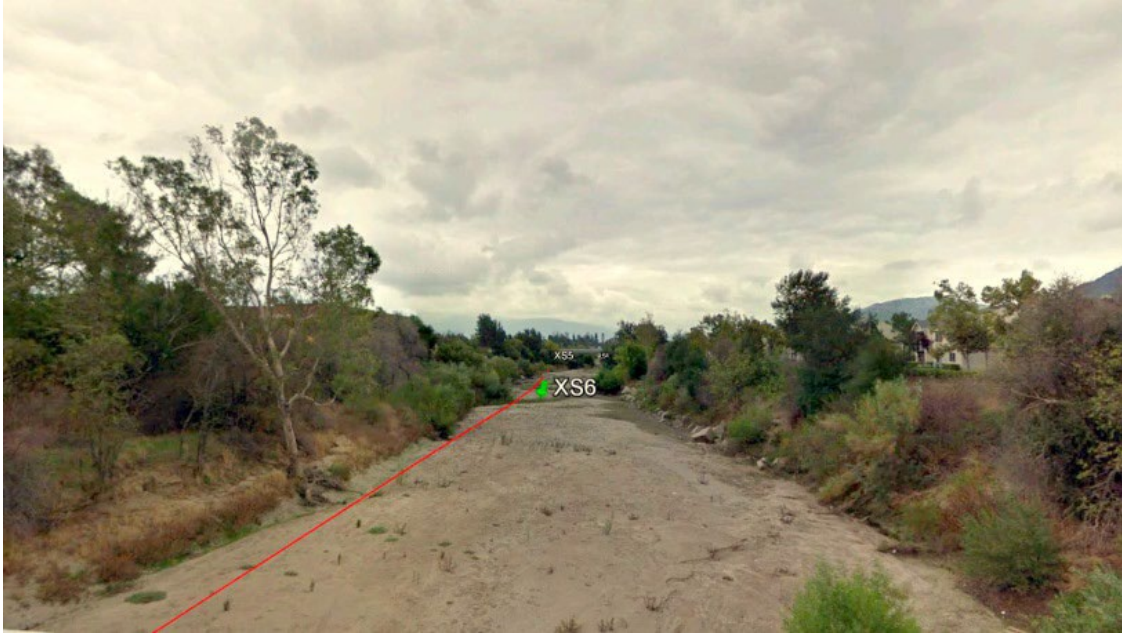
Figure B3.10. View downstream from Main Street bridge.

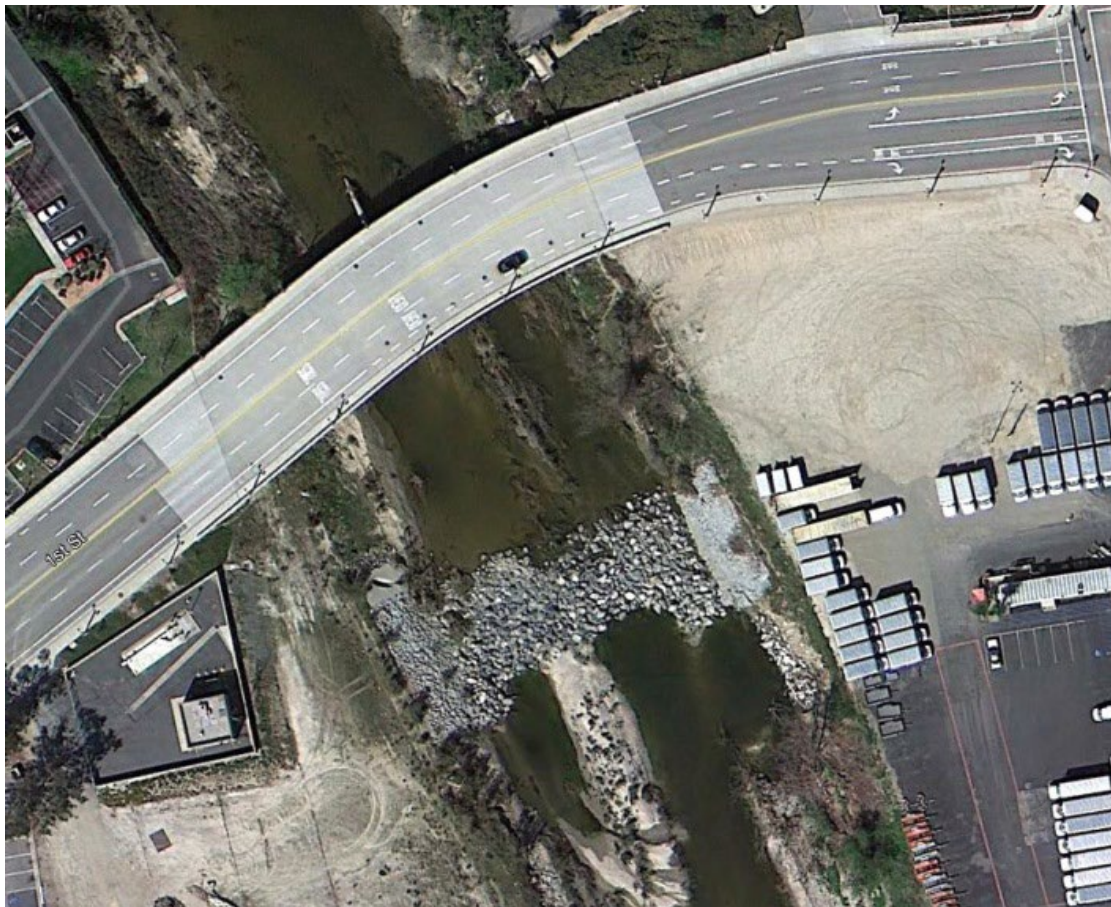
Figure B3.11. Aerial view (2011) of grade control structure constructed downstream from 1st Street Bridge.

In the case of this site, a riprap grade control structure was installed downstream from the 1<sup>st</sup> Street bridge ca. 2004 (Figure B3.11). Presentation of design criteria for grade controls is beyond the scope of this document. However, properly designed grade controls placed downstream from bridges can be effective countermeasures against failure due to undermining by erosion. Evidently the Murietta Creek grade control structure crest elevation was set high enough to protect both the 1<sup>st</sup> Street and the Main Street bridges, prompting sediment deposition at both locations that filled the areas around the exposed pier footings. Long term evolution of the channel of Murietta Creek will continue to be influenced by development and changes in watershed land cover, and a major flood control project is planned for this reach, also.

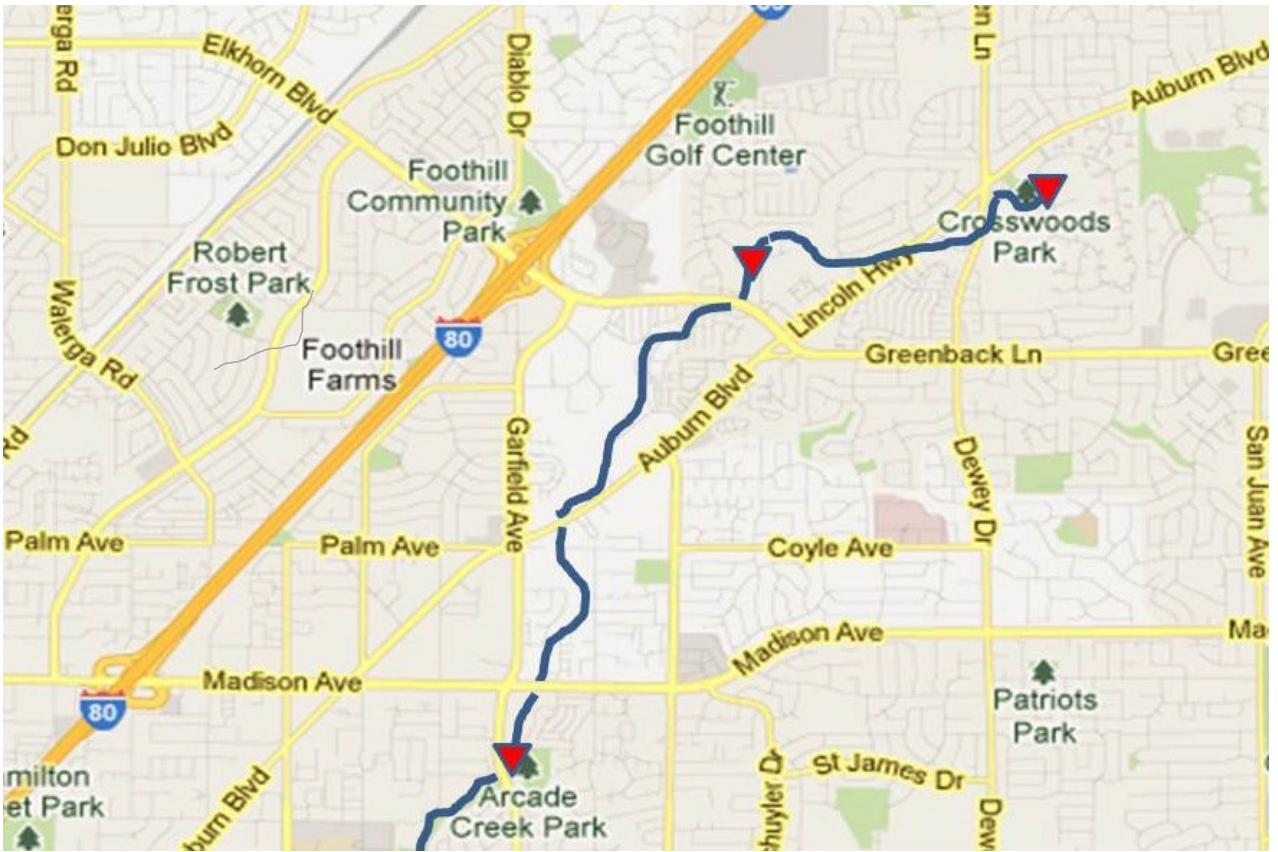
Figure B4.1. Example 4 site map. Red triangles show locations of crossings slated for replacement.

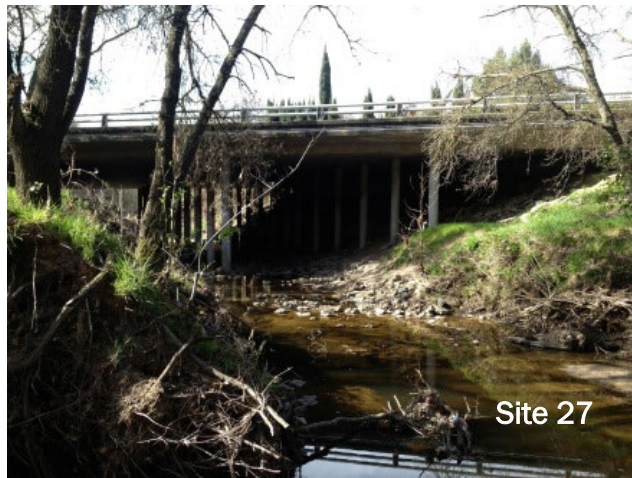
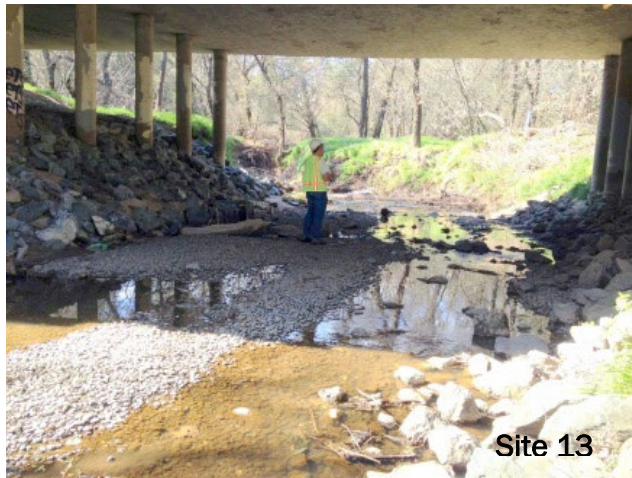
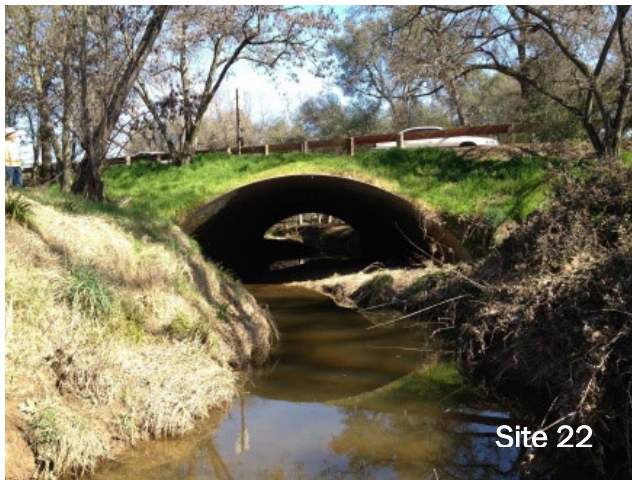
Figure B4.2. Ground level views of existing crossings of Arcade Creek, Citrus Heights, CA, at the three sites included in the project for Example 4.

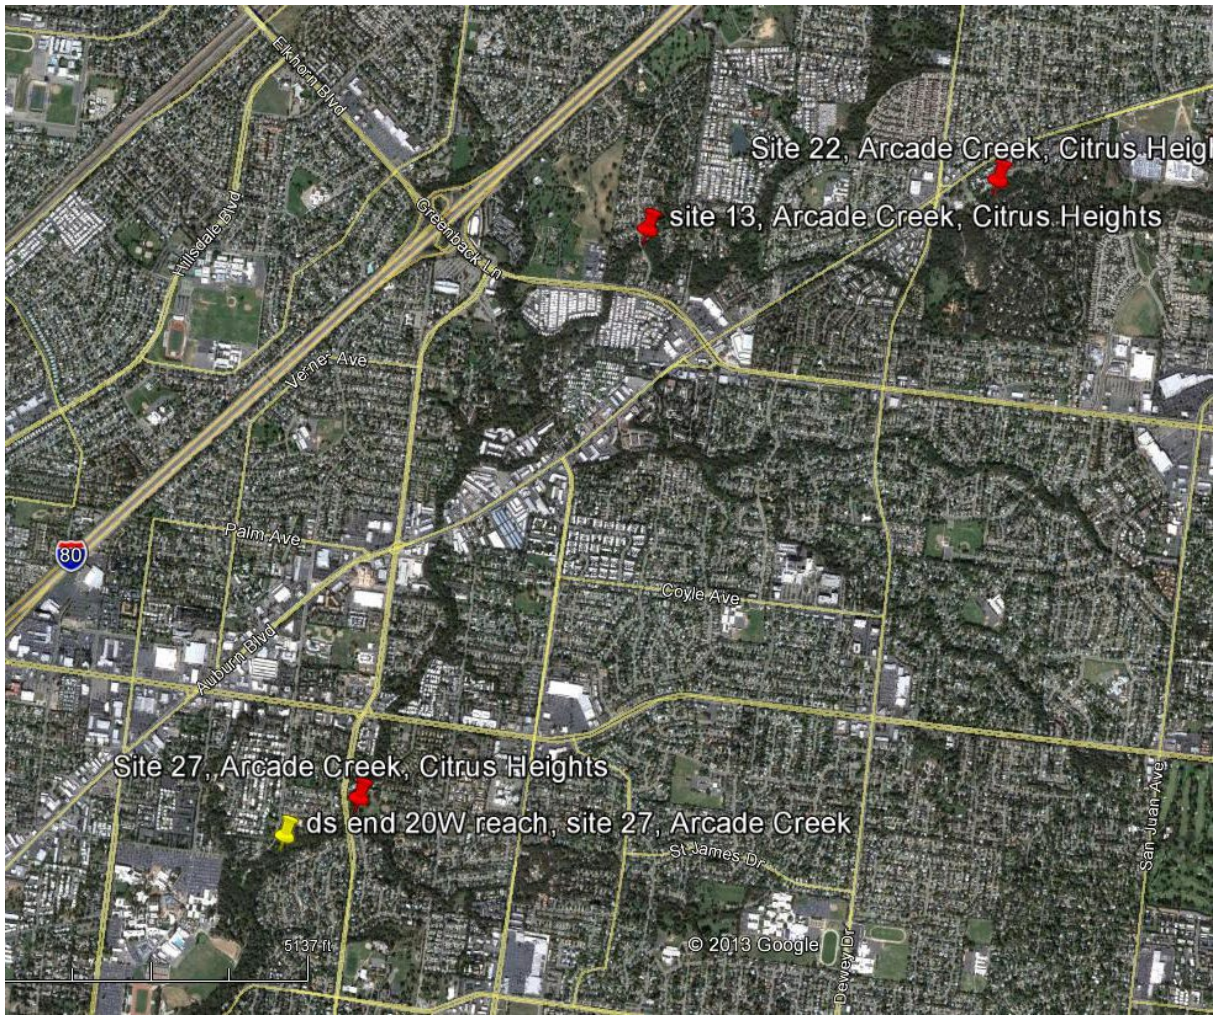
Figure B4.3. Yellow icon shows location of point for delineation of threshold drainage area at 20 channel widths (20W) downstream from site 27. Arcade Creek is shown by the forested corridor that runs from northeast to southwest.

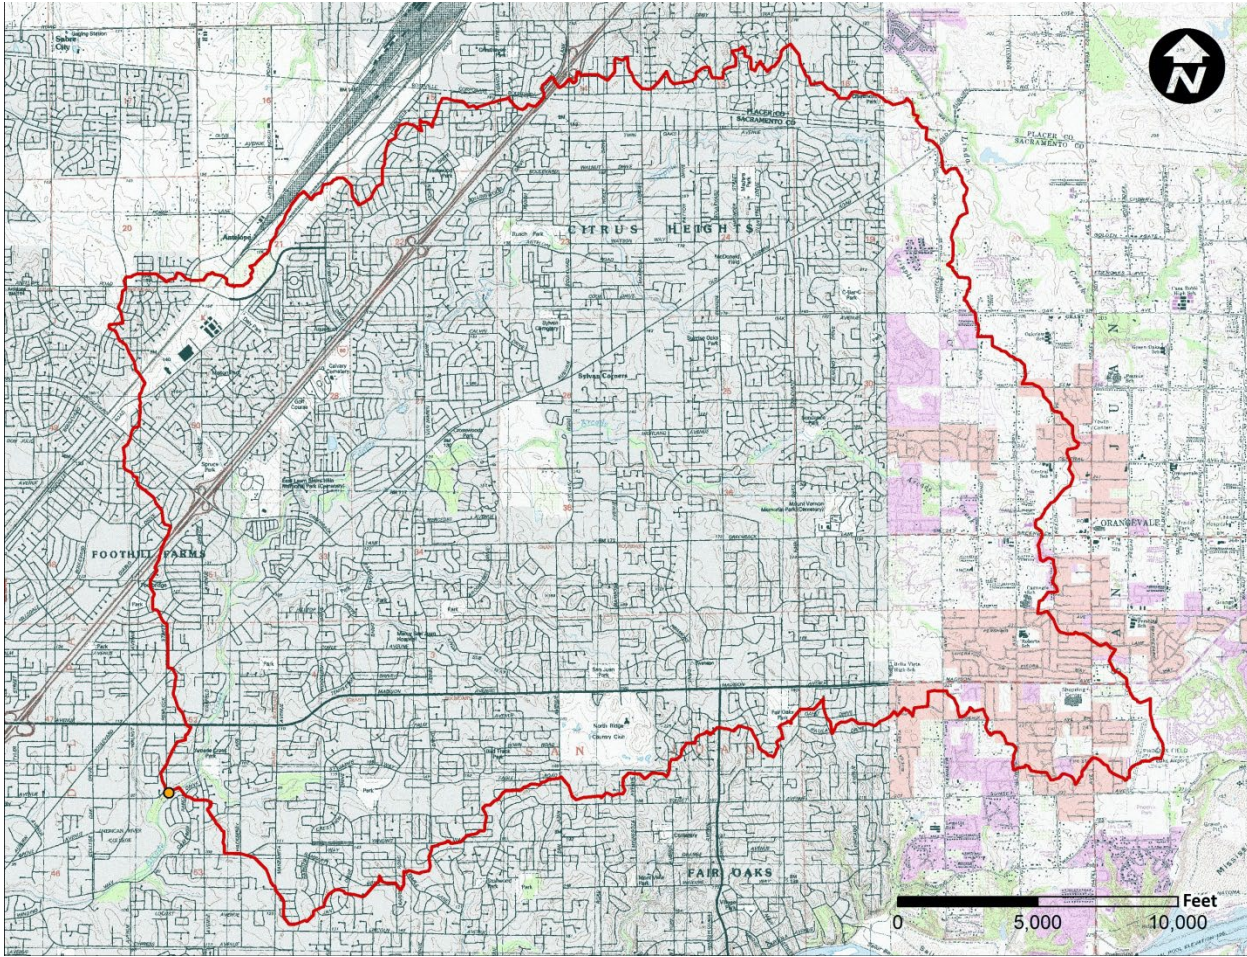
Figure B4.4. Threshold drainage area, Example 4.

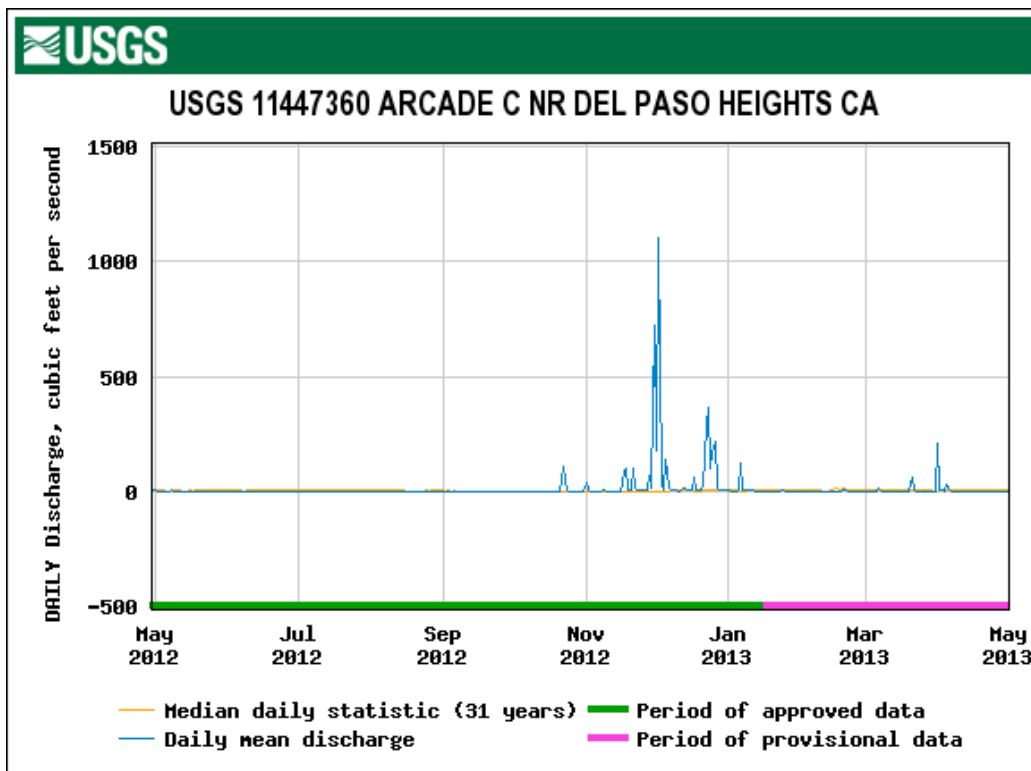
Figure B4.6. Daily mean discharge for USGS gaging station downstream from TDA. From [http://nwis.waterdata.usgs.gov/nwis/inventory/?site\\_no=11447360](http://nwis.waterdata.usgs.gov/nwis/inventory/?site_no=11447360).

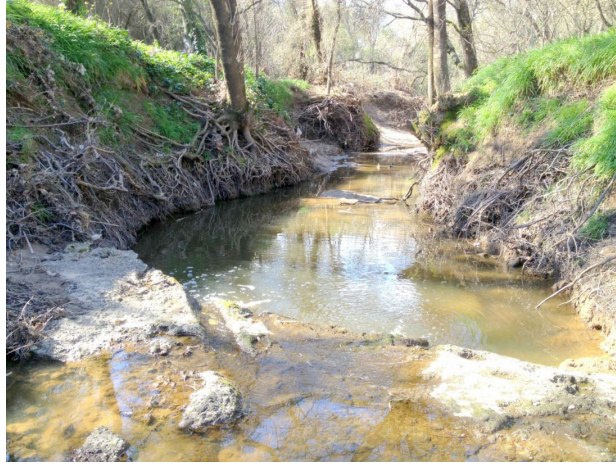
Figure B4.7. Arcade Creek site 13. Exposed tree roots in banks, leaning tree trunks, small width to depth ratio, and vertical drop at concrete apron in foreground are collectively diagnostic for channel incision.

Scores for this indicator were 7-8. Bank vegetation was comprised of a thin but fairly dense band of trees growing at the top of both banks. Several banks featured exposed roots and leaning trees (Figure B4.7, Figure B4.8 and Figure B4.9). Seasonal grasses covered bank slopes, but these are temporary and not flow-resistant. No significant engineered bank protection was found.
