**Caltrans Hydromodification/Stream Channel Stability  
Requirements Guidance  
*Storm Water Best Management Practices  
Rapid Assessment of Stream Crossings  
Higher Level Stream Stability Analysis***

**November 2023**

**California Department of Transportation  
1120 N Street  
Sacramento, California 95814**

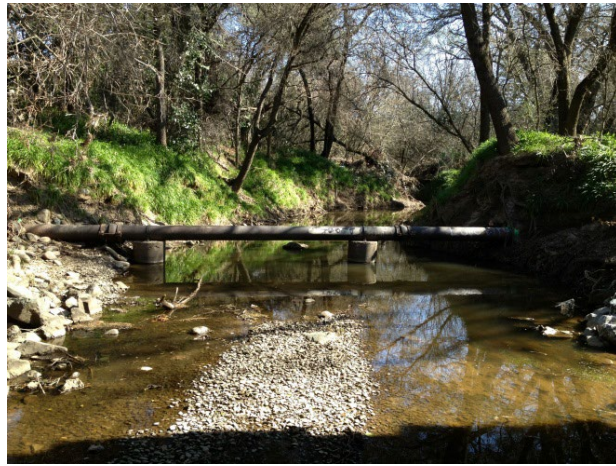
Figure B4.8. Typical Bed Material Size, Arcade Creek site 13. Note exposed pipeline, which is diagnostic of channel incision.

Scores for this indicator were 7-8. Bank vegetation was comprised of a thin but fairly dense band of trees growing at the top of both banks. Several banks featured exposed roots and leaning trees (Figure B4.7, Figure B4.8 and Figure B4.9). Seasonal grasses covered bank slopes, but these are temporary and not flow-resistant. No significant engineered bank protection was found.

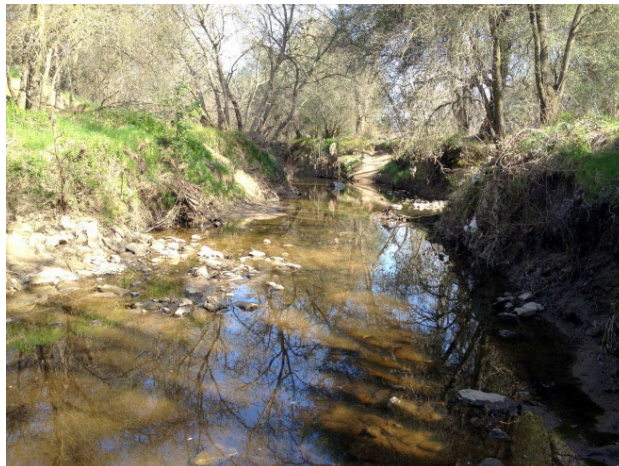
Figure B4.9. Typical Bank Conditions, Arcade Creek site 27.

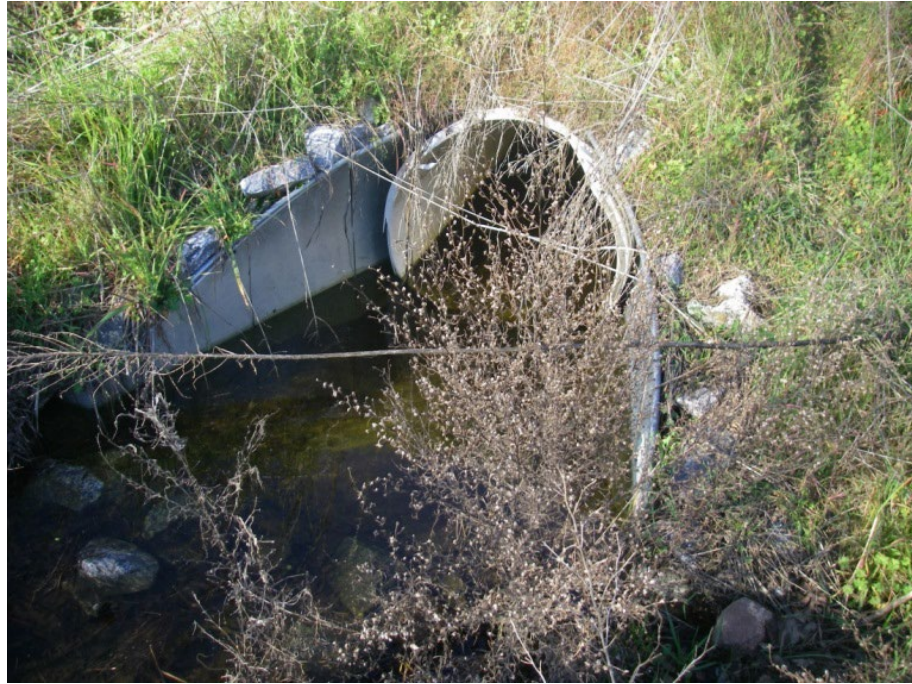
Figure B5.1. Flared outlet for Example 5 culvert.

This example is only loosely based on reality, the reader should be aware that some aspects of the example data are fictional and have been created for instructional purposes only. Lane addition is proposed for a 3.2-mile segment of highway, and there are 32 culverts within the project area. Since net new impervious area will total about 5 acres, RSAs are required for each culvert. The example shown is for a typical, 24-inch diameter corrugated metal pipe that is 10 years old (Figure B5.1).

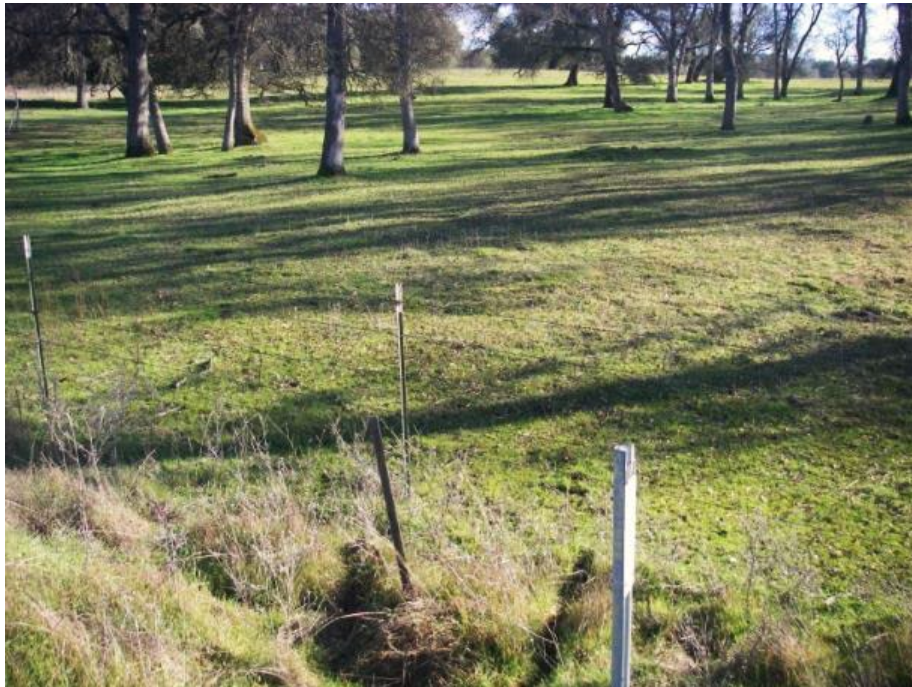
Figure B5.2. Area upstream of culvert inlet for Example 5.

Bed material for this reach is loamy soil protected by healthy turf grass (Figure B5.2). This type of bed surface is not covered in the scheme of Table 6. However, since this material is quite stable for the current and likely future flow conditions, bed material scores were 2 for both reaches.
