# Bridge Design Details 6.6 February 2020

## Bearing Pad Location at Anchorage Blockout

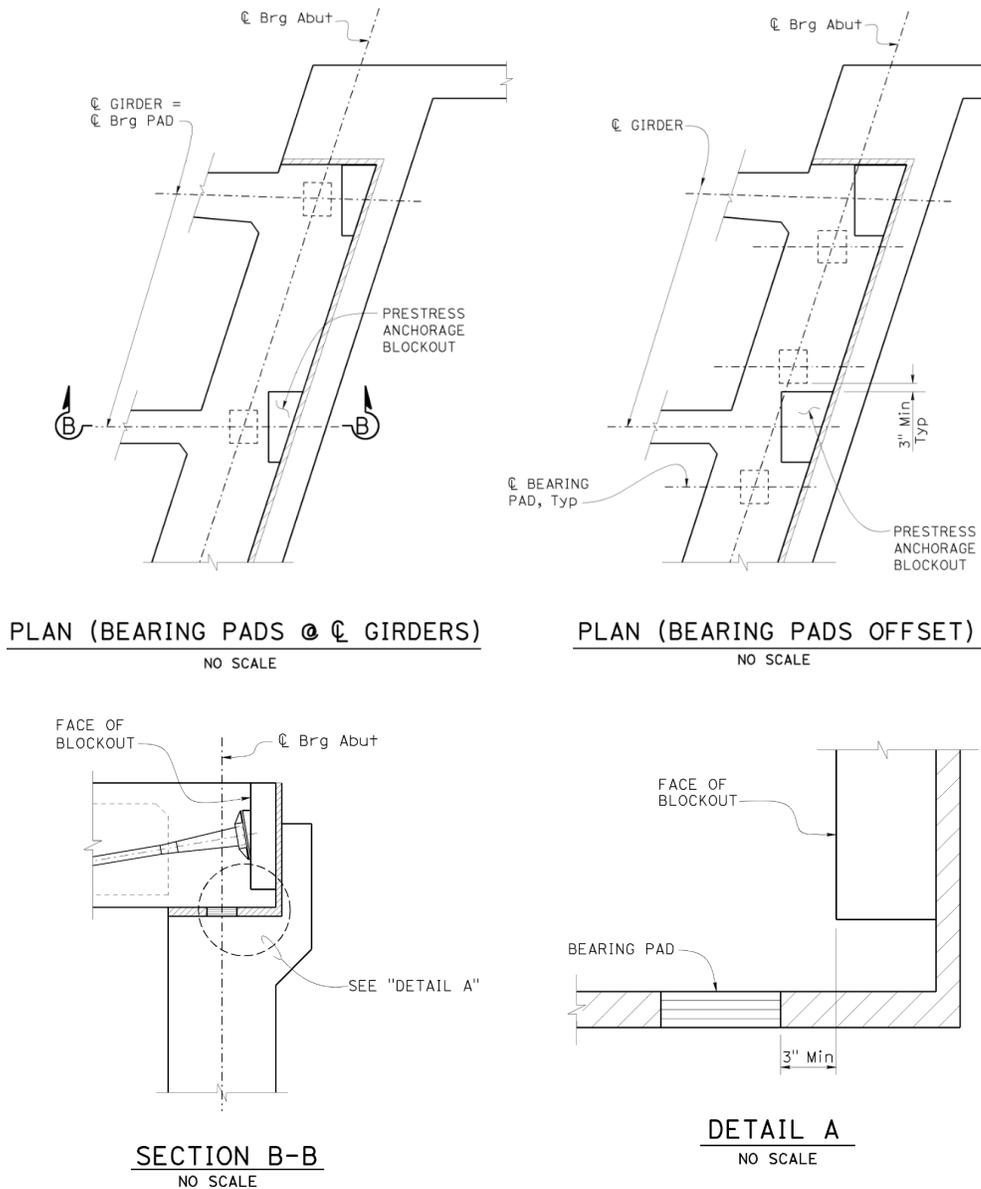
**Figure 6.6.1 Bearing Pad Location at Anchorage Blockout**
